A choice between Life and Death

Jenelle Hartman

Victoria Police

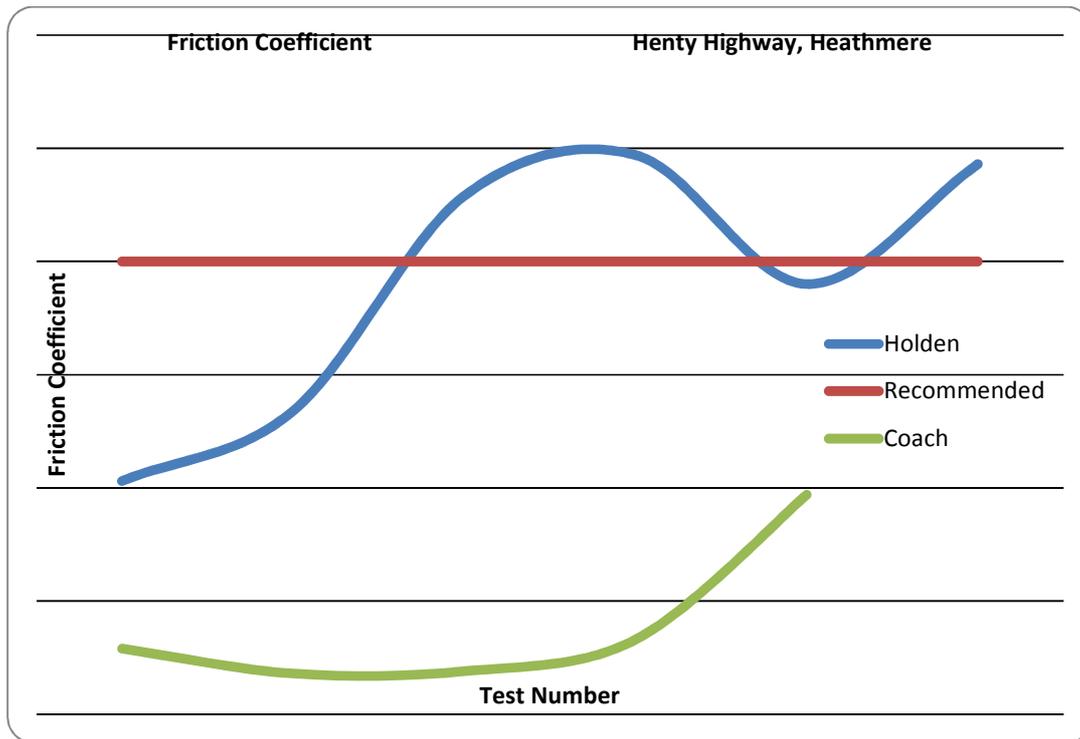
Fig. 2 Friction Coefficient of large sedan and coach on Henty Highway, Heathmere

It is clearly evident from Fig. 2 that the friction coefficient determined from the skid resistance test in the Austral Coach that all results fell well below the Vic Roads recommended levels. It must be noted however that the recommended levels are set in relation to passenger vehicles. When comparing the results of the Holden Omega sedan with the recommended levels it is apparent that the results obtained generally fall near to or below the Vic Roads recommended levels. Major Highways in Australia carry large volumes of heavy vehicles including trucks and coaches. Consideration must be given to the reduced friction coefficient that these vehicles have in comparison to passenger vehicles.
