The Effectiveness of the Application of High Friction Surfacing on Crash Reduction

Iskander, R (Pavement Services Manager) & Stevens, A (Senior Traffic Engineer)

Beca Infrastructure Ltd, Auckland, New Zealand

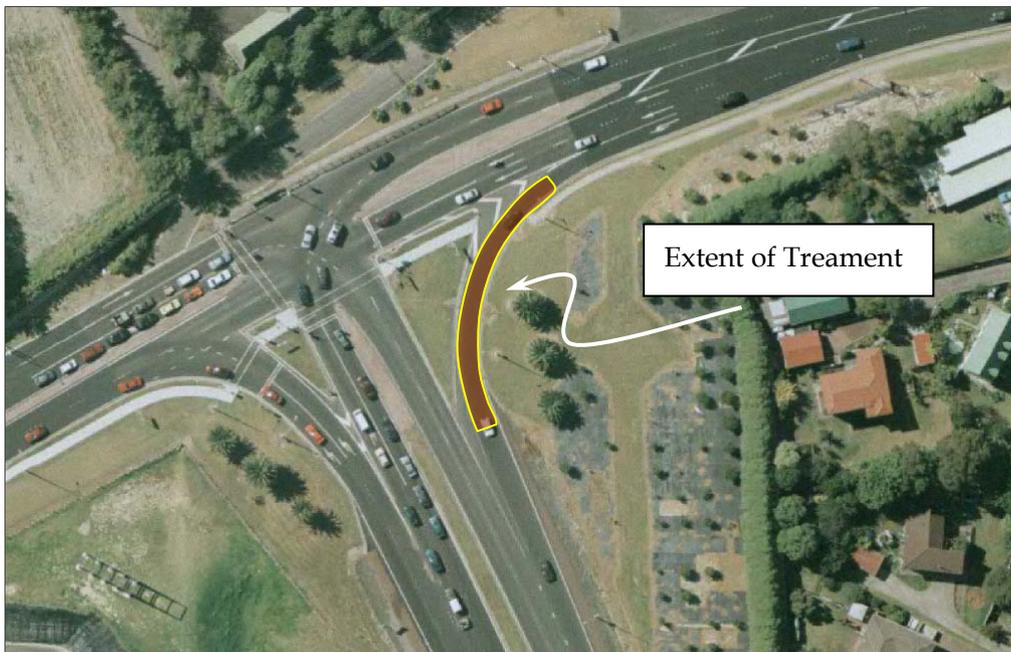
Figure 1

This was the first of the Auckland motorway sites to be treated with calcined bauxite. This site had proved problematic for some time prior to this treatment with respect to 'DB' loss of control type crashes while cornering. The key issue with the site is the relatively tight on ramp radius combined with the drivers expectation of being able to accelerate up to motorway speeds.

The aerial photo below shows the horizontal geometry and the extent of the calcined bauxite treatment at this site.

Consideration was given to altering the super elevation of the curve but this was not practical based on the funding criteria at the time. Consideration was also given to repositioning the speed advisory sign and adding a 'Turn left with care' sign, however it was not felt that they would have any more than a minor impact. The final recommendation was to trial a calcined bauxite treatment at this site.

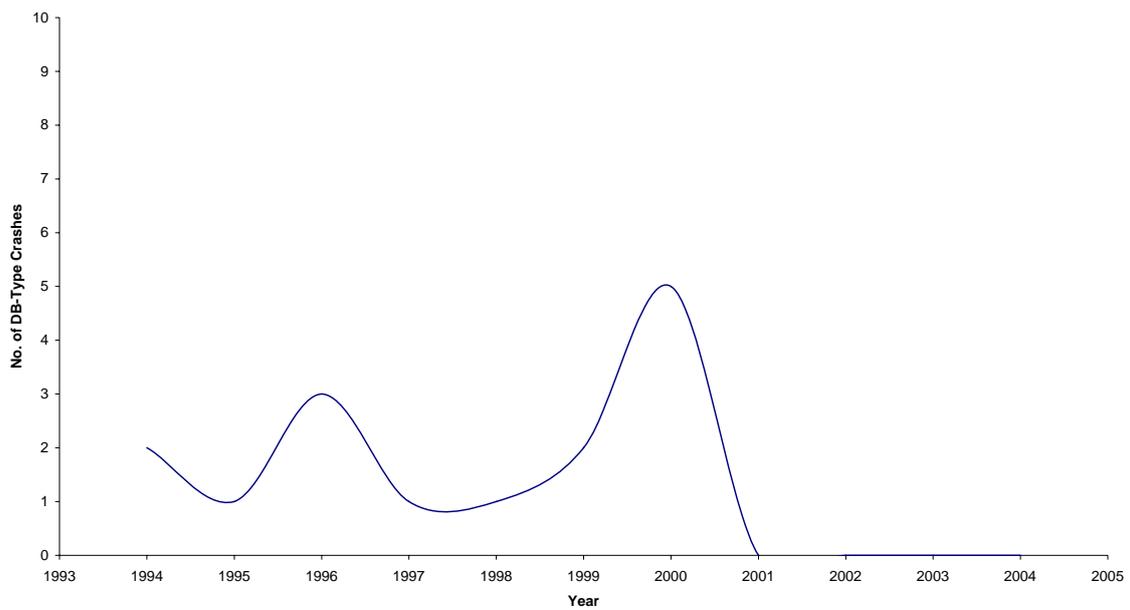
Figure 2
Reported Crash History, 1994 - 2004

It is evident from the reported crash history that the use of calcined bauxite at this site has been a great success. This site was treated in April 2001 and no loss of control type crashes have been reported since the calcined bauxite was put in place and no other crash types are being reported on the treated section of this on ramp.

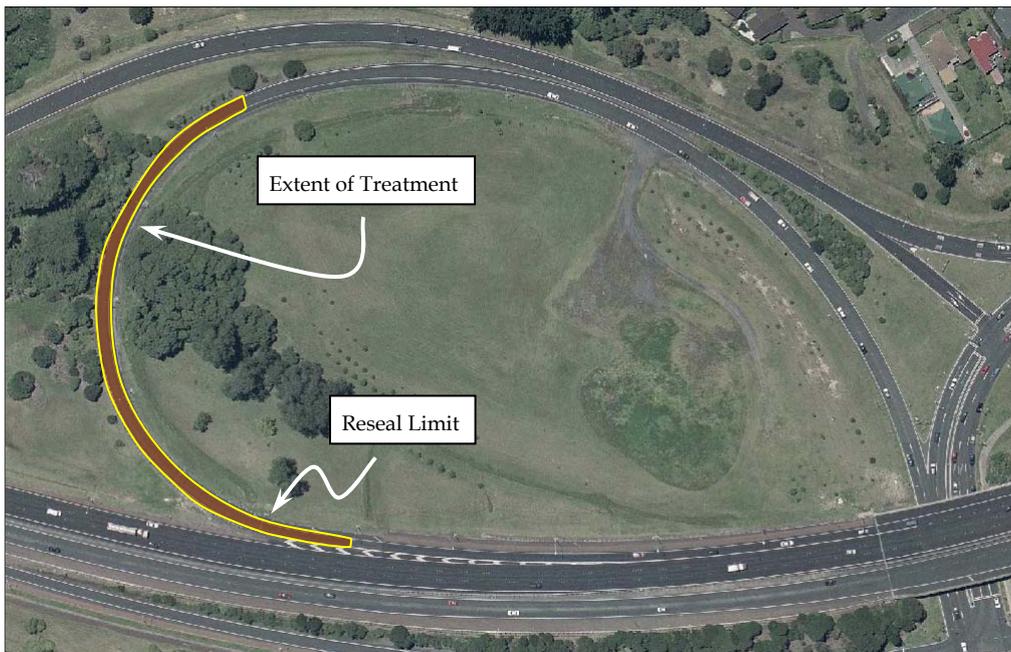
Figure 3
Great North Road On Ramp
Aerial Photo

This was the second Auckland motorway site to be treated with calcined bauxite. This site had proved problematic for some time prior to treatment and had a poor crash history. The key issue with the site is that the ramp radius tightens on the approach to the motorway merge. Being a motorway on ramp, motorists are inclined to try to accelerate up to motorway speed despite the decreasing radius and the 55kph speed advisory sign. The consequence is the concentration of reported loss of control crashes at this site.

Other issues and features of this site include a pavement surface that is kept in the shade and is damp due to adjacent trees and watercourse; a seal joint near the end of the on ramp, that is part way through a horizontal curve; and traffic merging across the painted gore area.

The aerial photo of the site shows the horizontal geometry, the extent of the calcined bauxite treatment, the vegetated area and the location of the two adjacent seal areas.

The bulk of these crashes were addressed by two additional remedial works. The first measure was to redefine the seal programme extents to move the current seal limit on the on ramp further east to a point where it was no longer on the horizontal curve. The problem was that the two adjacent seals were being done at different dates and wearing differently meaning a change in surface friction from one seal to the next, hence resulting in loss of control type crashes. The second measure was to install safe hit posts to stop motorists from crossing the painted gore area, as it appeared that motorists were losing control on paint markings themselves.

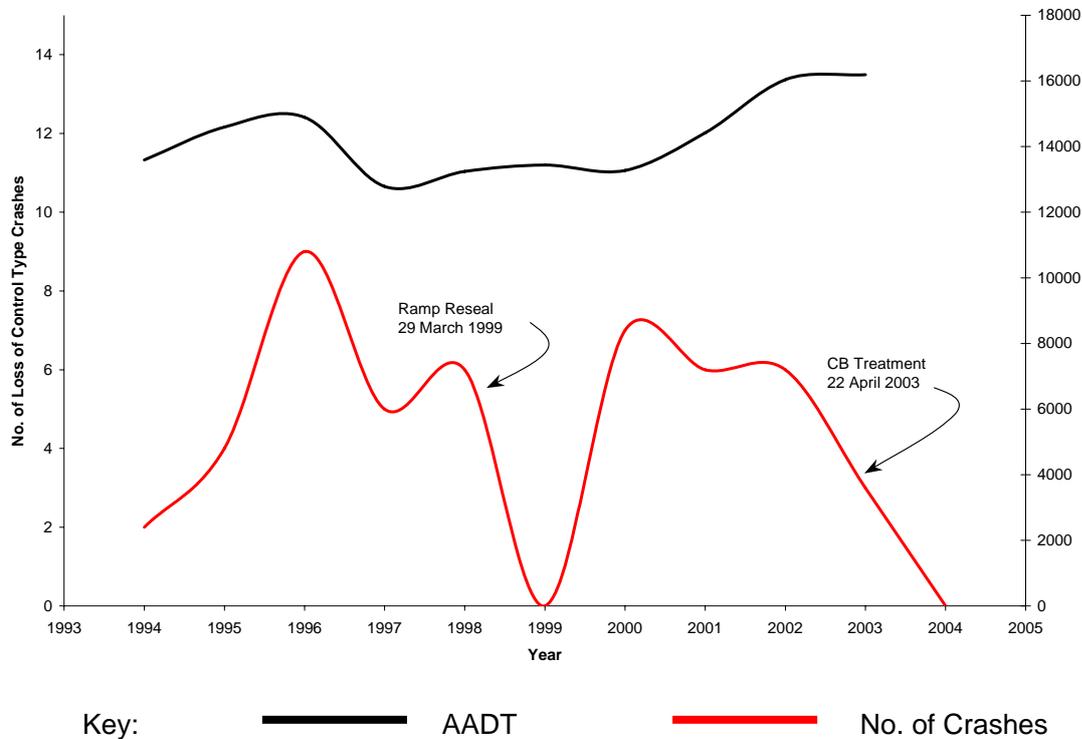
The crashes contained in Table 2 and Figure 4 relate solely to the crashes considered to be a consequence of the horizontal geometry of the on ramp and do not include any merging type crashes.

This on ramp was resealed in its entirety in March 1999 with OGPA. As could be expected this resulted in an immediate reduction in the number of crashes being reported. In fact there were no crashes for a nine month period, but after this time as the surface polished the crash problem returned. As of February 2005, it is 22 months since the calcined bauxite treatment was implemented and only one loss of control type crash has been reported. This solitary crash involved a truck; and the TCR indicates that the driver was charged with careless driving. Hence it was unlikely that any engineering solution would have prevented that crash. While it is still early in the monitoring period, it is expected that this site will continue with its impressive start to eliminating the loss of control problem at this site.

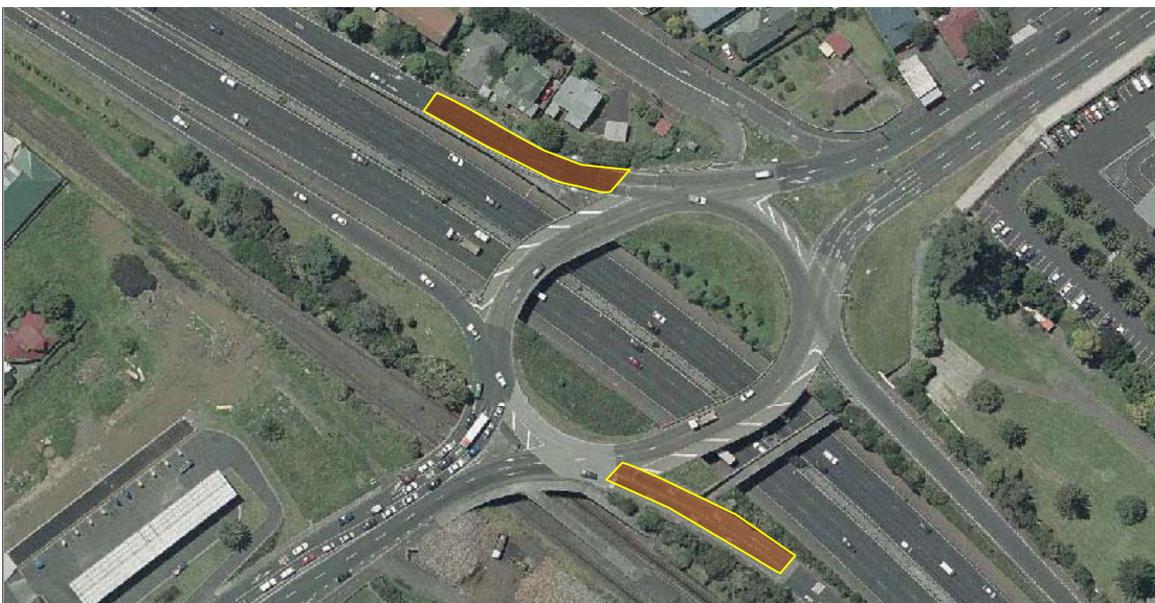
Figure 5
Greenlane Interchange

Both the Greenlane and the Ellerslie-Penrose (see next section) Interchanges have been monitored continuously from the onset of the Motorway CRS Studies in 1992. Both interchanges have an overhead roundabout connecting the on and off ramps and feed key urban arterial roads. Both sites are very heavily trafficked and have had a poor crash record. Both have had different calcined bauxite treatments applied.

The aerial photo below shows the Greenlane Interchange and the extent of the calcined bauxite treatment at this site.

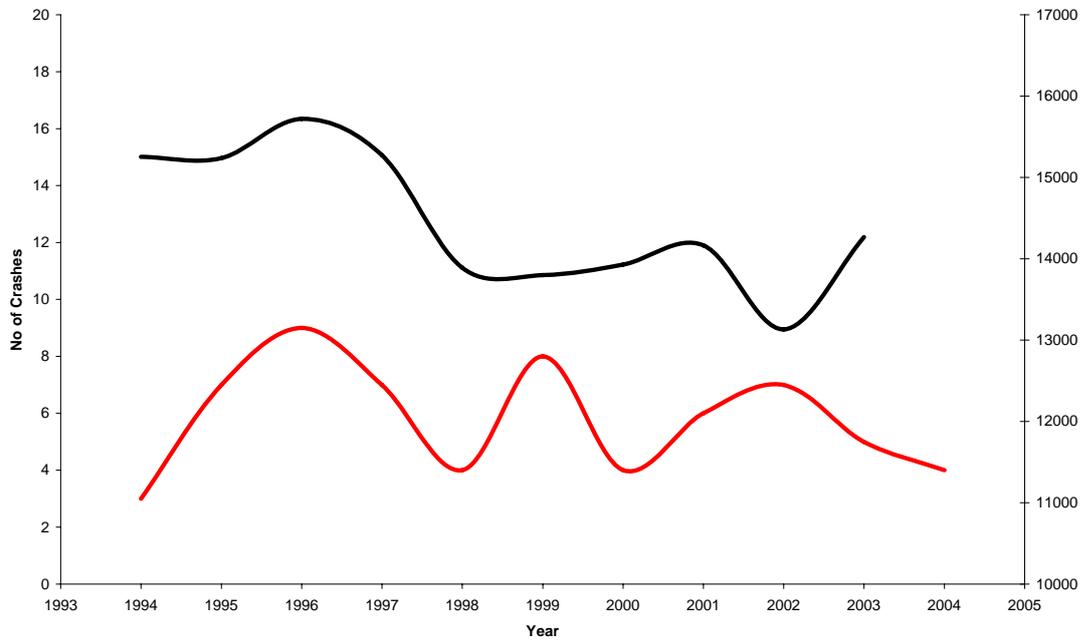
Figure 6
 Greenlane Off Ramp, Southbound
 Reported Crash History, 1994 - 2004

Both the Greenlane on and off ramps were treated with a calcined bauxite surfacing in January 2002. The ensuing three years has indicated little change in the number of crashes or any change in crash severity. It is known that this site initially had some problems with delamination of the calcined bauxite, a problem that has been evident at several sites throughout Auckland. However the delamination, which has since been rectified is not considered to have impacted on the lack of reduction in the number of crashes being reported.

It is our opinion that the key issue with this site is the high level of congestion that is present in terms of the lack of noticeable improvement in the crash trends. This interchange serves a key urban arterial road (Greenlane East and West) and hence is heavily trafficked throughout the day and highly congested during the morning and evening commuter peak periods. It is therefore now appears that the provision of a high friction surfacing will have little impact on the crash record. This is primarily due to driver impatience and aggressiveness resulting in following distances between vehicles that are generally too small and the hence the reaction time is insufficient to prevent the crashes from occurring, regardless of the surfacing. Hence the choice of this type of surfacing treatment should be used with caution at sites such as this. While very early in the monitoring period, it is anticipated that the Ellerslie-Penrose site will display similar results.

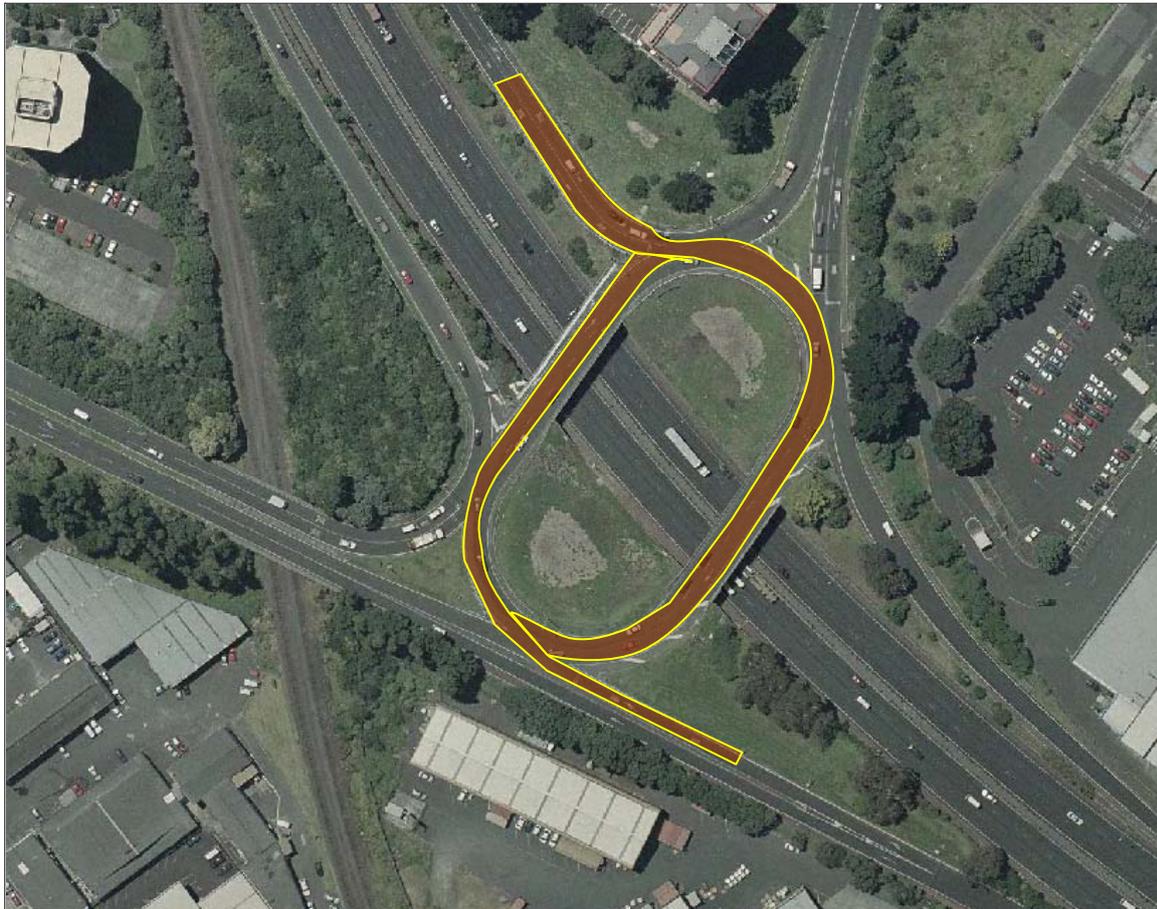
Figure 8

The aerial photo following shows the Ellerslie-Penrose Interchange and the extent of the calcined bauxite treatment at this site.

Like the Greenlane interchange, this site is heavily trafficked throughout the day and highly congested during the commuter peak periods.

This site has had both of the off ramps as well as the circulating lanes of the roundabout sealed with calcined bauxite. This was undertaken in June 2004, meaning that the monitoring period is too short to start to draw any conclusions from, especially as the CAS database is unlikely to be up to date with the last six months data from 2004. Taking this into account, it would appear that like the Greenlane site, the calcined bauxite is going to have little effect on reducing the number of crashes at this site. This again is due to the high level of congestion present and reaction times being insufficient for the following distances and aggressiveness displayed by drivers at this location.
