Cleaning Open Grade Asphalt to Improve Safety

Richard Lane
Pavement Treatments Ltd.

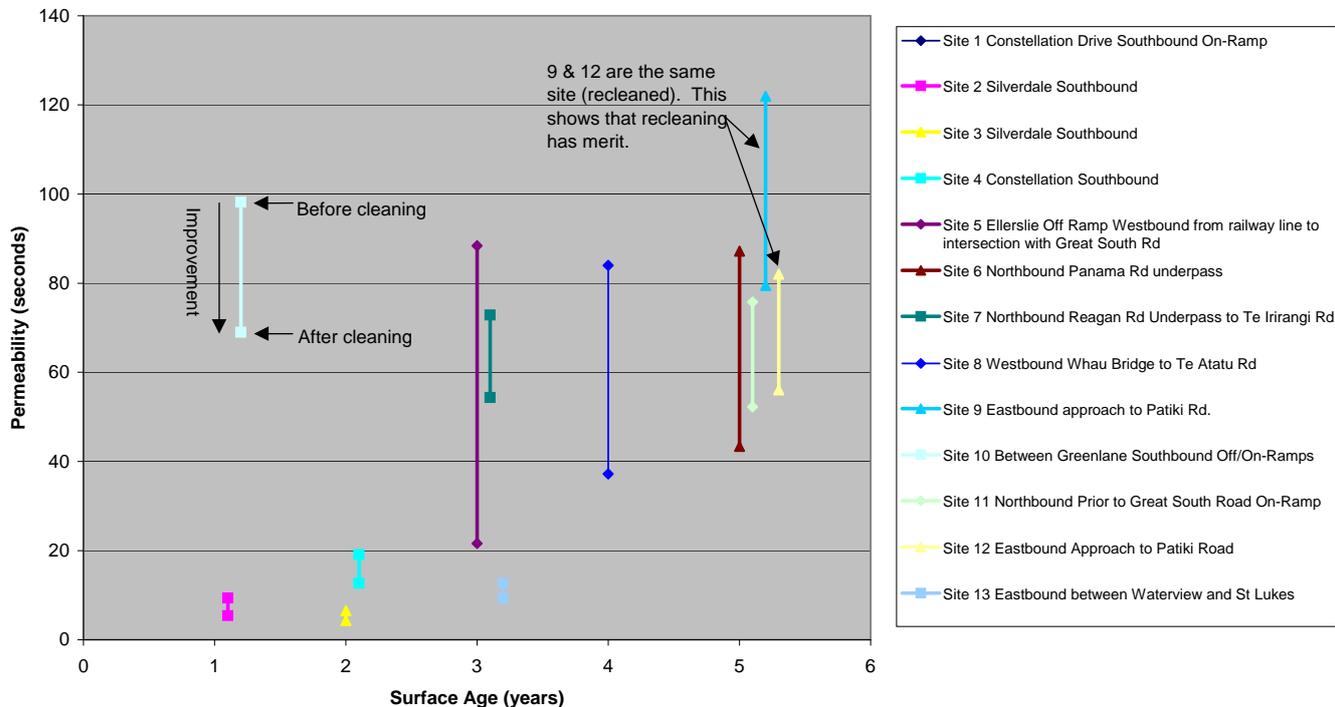
OGPA Permeability against Surface Age

Figure 1 shows a summary graph of the average permeability readings plotted against surface age. This shows which sites improved more than others. The graph shows the average permeability reading of the OGPA before the site was cleaned and the permeability reading after cleaning was completed. The decrease in permeability time shows the improvement achieved in OGPA drainage. Site 10, between the Greenlane southbound off and on ramps, has been used an example to demonstrate how the chart should be interpreted.

Figure 1 shows clearly that sites of three years or older can have significant improvements in permeability achieved. Sites 9 and 12 (which are in fact the same location) show that repeated cleaning has merit. It would be interesting to discover if further recleaning could achieve an even better permeability outcome.
