The Effectiveness of the Application of High Friction Surfacing on Crash Reduction

Iskander, R (Pavement Services Manager) & Stevens, A (Senior Traffic Engineer)

Beca Infrastructure Ltd, Auckland, New Zealand

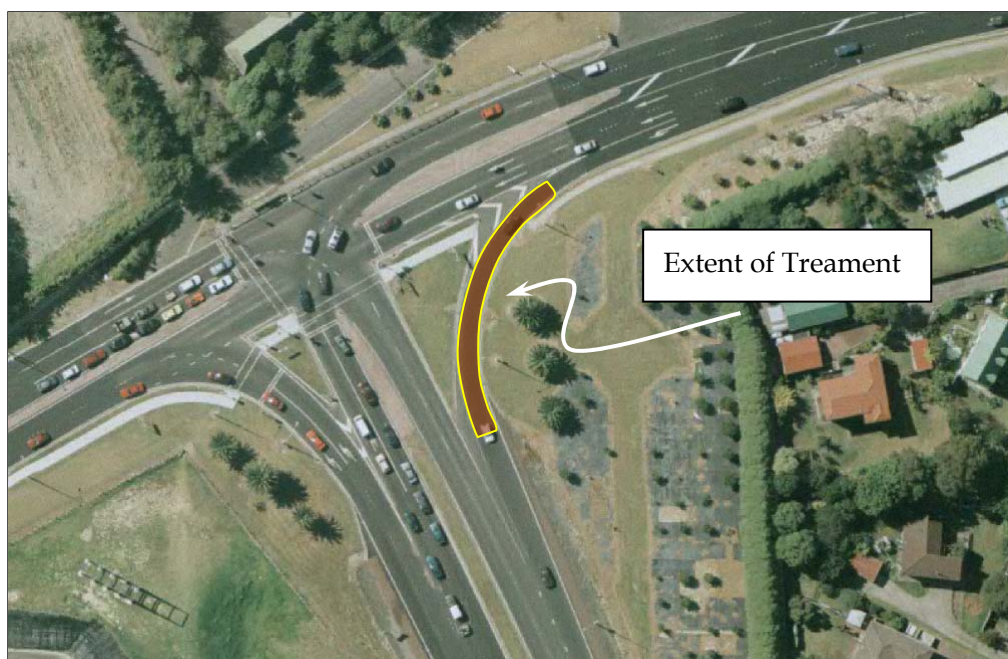
Figure 1

This was the first of the Auckland motorway sites to be treated with calcined bauxite. This site had proved problematic for some time prior to this treatment with respect to 'DB' loss of control type crashes while cornering. The key issue with the site is the relatively tight on ramp radius combined with the drivers expectation of being able to accelerate up to motorway speeds.

Northwestern Motorway, SH16 / 18 Intersection, Eastbound

Consideration was given to altering the super elevation of the curve but this was not practical based on the funding criteria at the time. Consideration was also given to repositioning the speed advisory sign and adding a 'Turn left with care' sign, however it was not felt that they would have any more than a minor impact. The final recommendation was to trial a calcined bauxite treatment at this site.

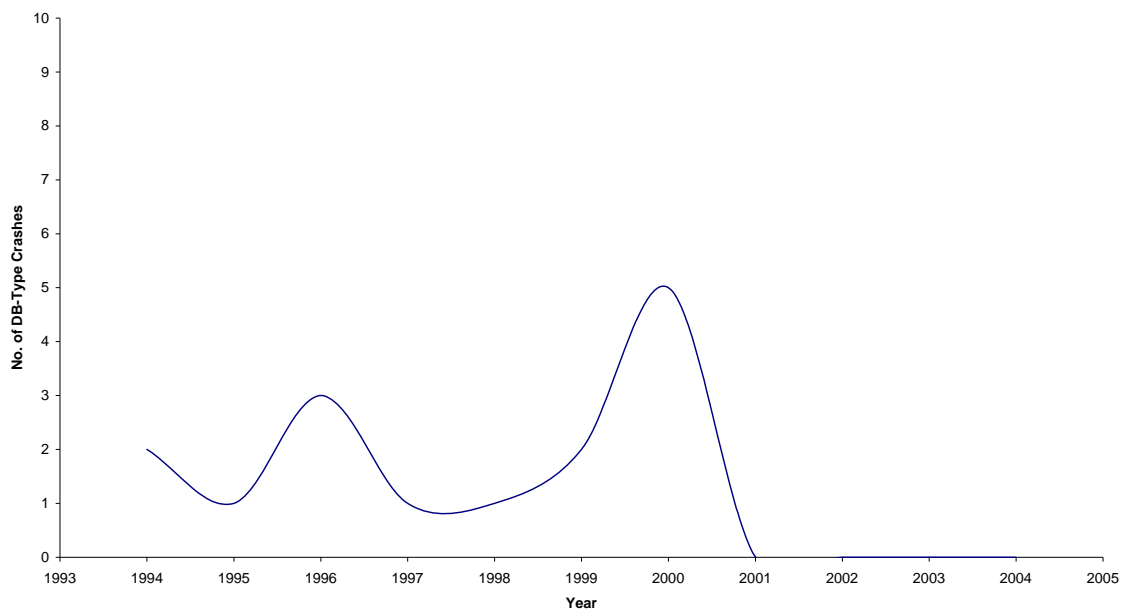
Figure 2
Reported Crash History, 1994 - 2004

It is evident from the reported crash history that the use of calcined bauxite at this site has been a great success. This site was treated in April 2001 and no loss of control type crashes have been reported since the calcined bauxite was put in place and no other crash types are being reported on the treated section of this on ramp.

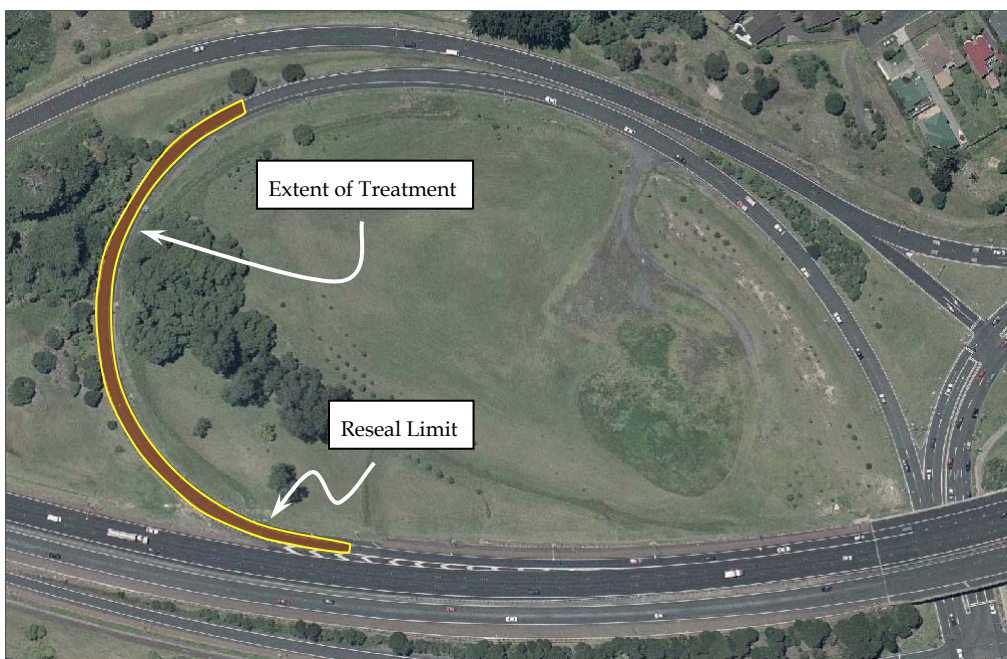
Figure 3
Great North Road On Ramp
Aerial Photo

This was the second Auckland motorway site to be treated with calcined bauxite. This site had proved problematic for some time prior to treatment and had a poor crash history. The key issue with the site is that the ramp radius tightens on the approach to the motorway merge. Being a motorway on ramp, motorists are inclined to try to accelerate up to motorway speed despite the decreasing radius and the 55kph speed advisory sign. The consequence is the concentration of reported loss of control crashes at this site.

Other issues and features of this site include a pavement surface that is kept in the shade and is damp due to adjacent trees and watercourse; a seal joint near the end of the on ramp, that is part way through a horizontal curve; and traffic merging across the painted gore area.

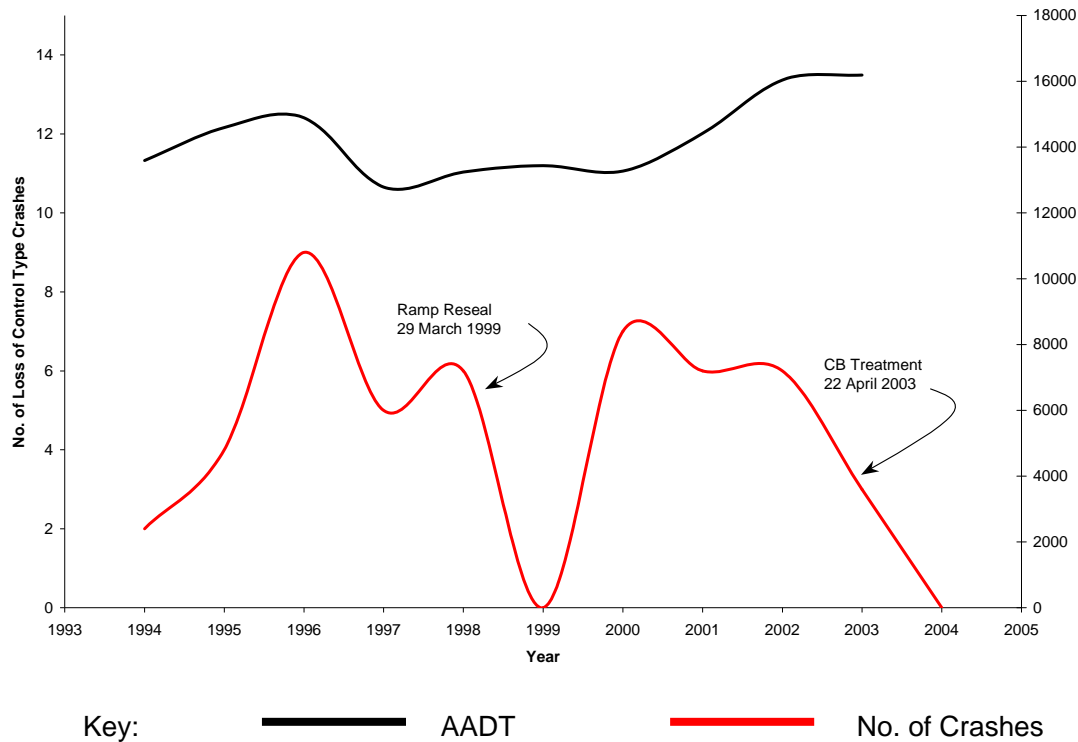
The crashes contained in Table 2 and Figure 4 relate solely to the crashes considered to be a consequence of the horizontal geometry of the on ramp and do not include any merging type crashes.

This on ramp was resealed in its entirety in March 1999 with OGPA. As could be expected this resulted in an immediate reduction in the number of crashes being reported. In fact there were no crashes for a nine month period, but after this time as the surface polished the crash problem returned. As of February 2005, it is 22 months since the calcined bauxite treatment was implemented and only one loss of control type crash has been reported. This solitary crash involved a truck; and the TCR indicates that the driver was charged with careless driving. Hence it was unlikely that any engineering solution would have prevented that crash. While it is still early in the monitoring period, it is expected that this site will continue with its impressive start to eliminating the loss of control problem at this site.

The bulk of these crashes were addressed by two additional remedial works. The first measure was to redefine the seal programme extents to move the current seal limit on the on ramp further east to a point where it was no longer on the horizontal curve. The problem was that the two adjacent seals were being done at different dates and wearing differently meaning a change in surface friction from one seal to the next, hence resulting in loss of control type crashes. The second measure was to install safe hit posts to stop motorists from crossing the painted gore area, as it appeared that motorists were losing control on paint markings themselves.

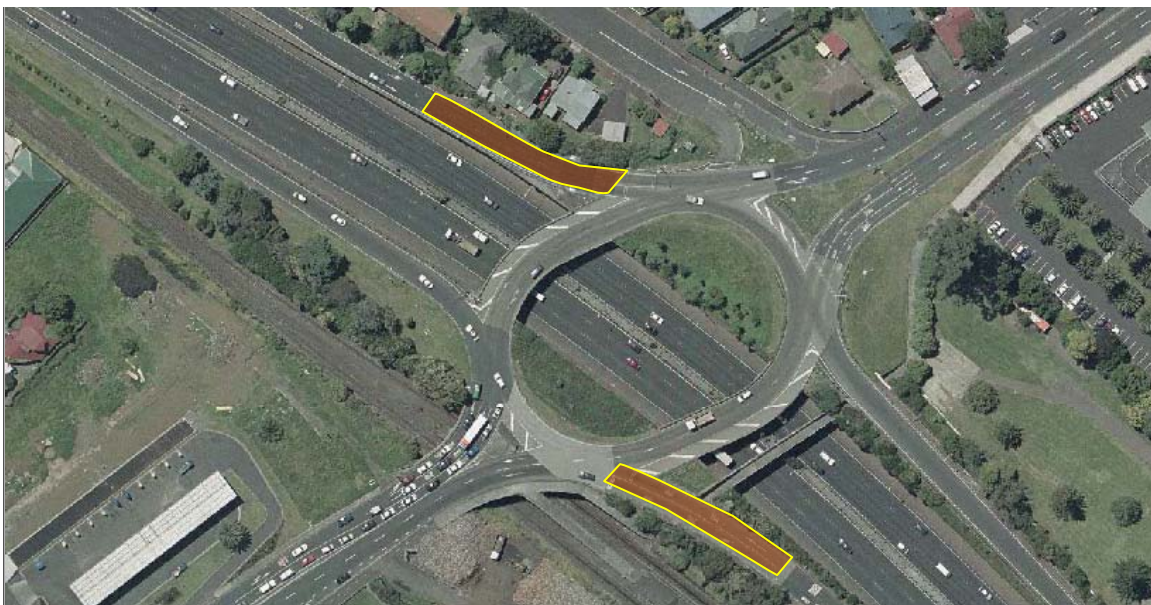
Figure 5
Greenlane Interchange

Both the Greenlane on and off ramps were treated with a calcined bauxite surfacing in January 2002. The ensuing three years has indicated little change in the number of crashes or any change in crash severity. It is known that this site initially had some problems with delamination of the calcined bauxite, a problem that has been evident at several sites throughout Auckland. However the delamination, which has since been rectified is not considered to have impacted on the lack of reduction in the number of crashes being reported.

With calcined bauxite being a contrasting colour to the typical SMA and OGPA, or any asphaltic surfacing, it is highly visible when any delamination occurs, even when it is only very small areas (say the size of a fifty cent coin) that is effected. Hence we believe that it is often results in an aesthetic issue rather than any real reduction in the over effectiveness of the treated site.

It is our opinion that the key issue with this site is the high level of congestion that is present in terms of the lack of noticeable improvement in the crash trends. This interchange serves a key urban arterial road (Greenlane East and West) and hence is heavily trafficked throughout the day and highly congested during the morning and evening commuter peak periods. It is therefore now appears that the provision of a high friction surfacing will have little impact on the crash record. This is primarily due to driver impatience and aggressiveness resulting in following distances between vehicles that are generally too small and the hence the reaction time is insufficient to prevent the crashes from occurring, regardless of the surfacing. Hence the choice of this type of surfacing treatment should be used with caution at sites such as this. While very early in the monitoring period, it is anticipated that the Ellerslie-Penrose site will display similar results.

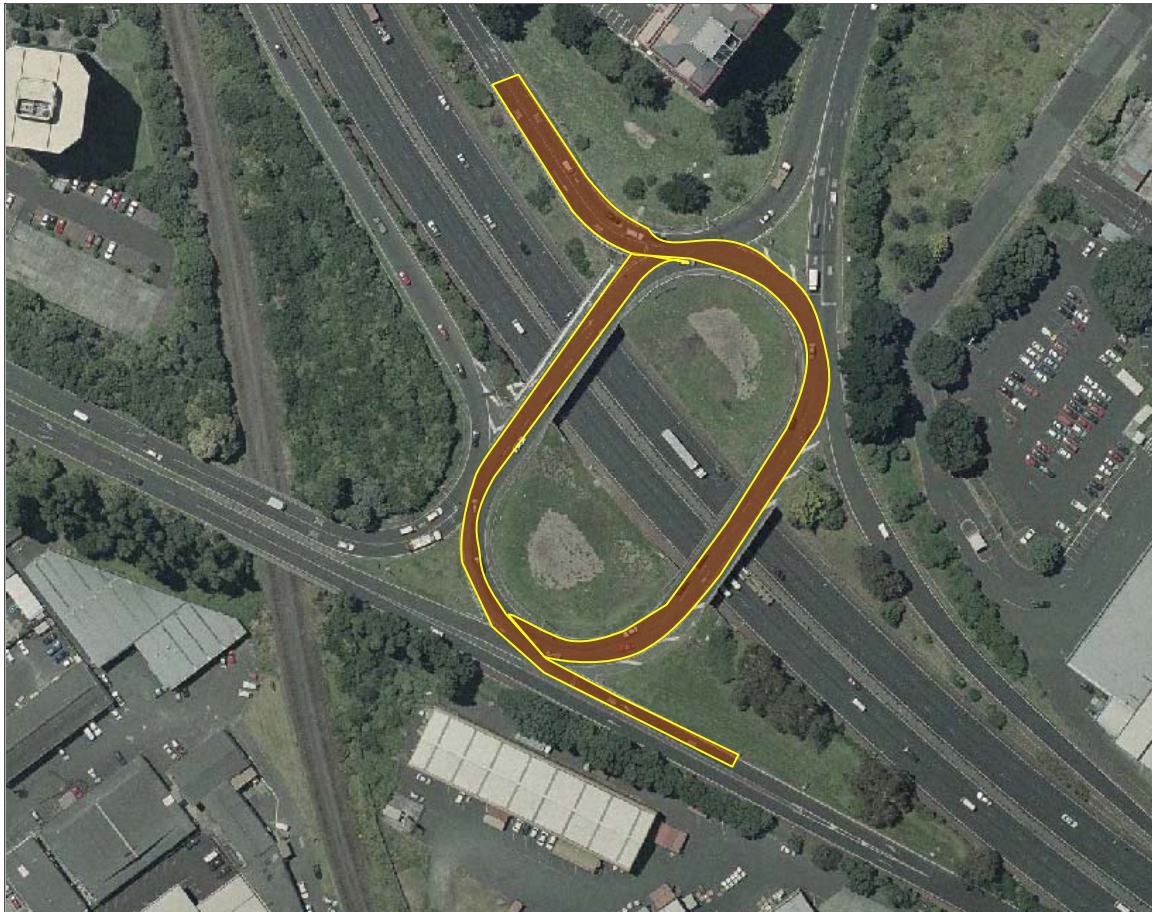
Figure 8

Extent of Calcined Bauxite Treatment

This site has had both of the off ramps as well as the circulating lanes of the roundabout sealed with calcined bauxite. This was undertaken in June 2004, meaning that the monitoring period is too short to start to draw any conclusions from, especially as the CAS database is unlikely to be up to date with the last six months data from 2004. Taking this into account, it would appear that like the Greenlane site, the calcined bauxite is going to have little effect on reducing the number of crashes at this site. This again is due to the high level of congestion present and reaction times being insufficient for the following distances and aggressiveness displayed by drivers at this location.
