HIGH FRICTION SURFACING FAILURE MECHANISMS

Jeff Waters, Fulton Hogan Ltd, New Zealand

This paper investigates the failures of a number of HFS systems that have been applied over the past five years in various situations in New Zealand with the aim to identify the mechanisms or combination of mechanisms that have contributed to the failures.

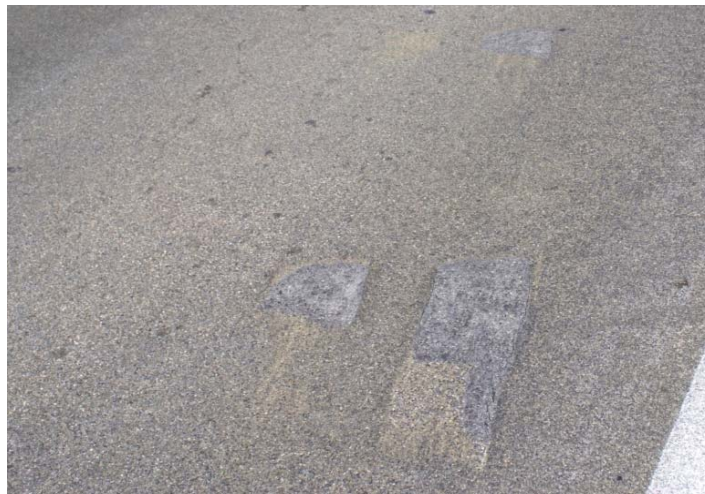
- Binder mixture is incorrect and does not cure.
- HFS is trafficked too early before the binder has cured properly. (Figure 1)
- Temperatures too cold and binder does not cure properly.
- Binder application rate is uneven and in areas where it is too low the bond contact area between the aggregate and the binder is insufficient to retain the CB. (Figure 2)

Figure 1: Traffic too early.

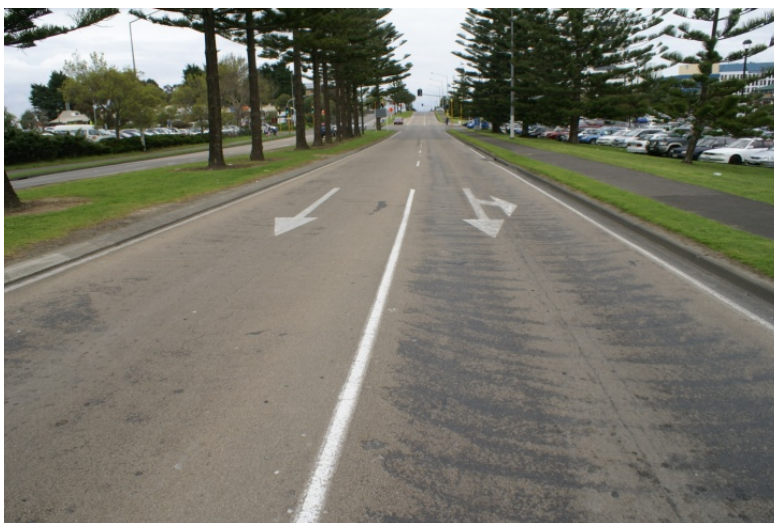
Figure 2: Poor binder application causing chip loss.

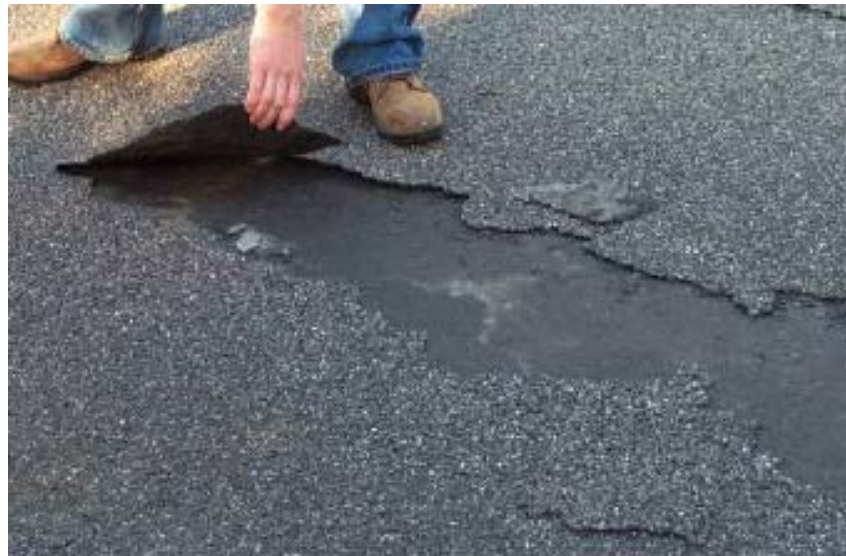
On the Wainuiomata Hill site, Hudson (1994) reported that water rising from the subgrade through the permeable asphalt substrate was breaking the bond between the binder and the asphalt surface (see Figure 3). Parfitt (2011) found when inspecting the failures on Wainuiomata Hill that there were also cohesive failures where the moisture caused stripping within the asphalt. He also suggested that the polyurethane binder used was less permeable than other binders in use.

Figure 3: Delamination on Wainuiomata Hill.

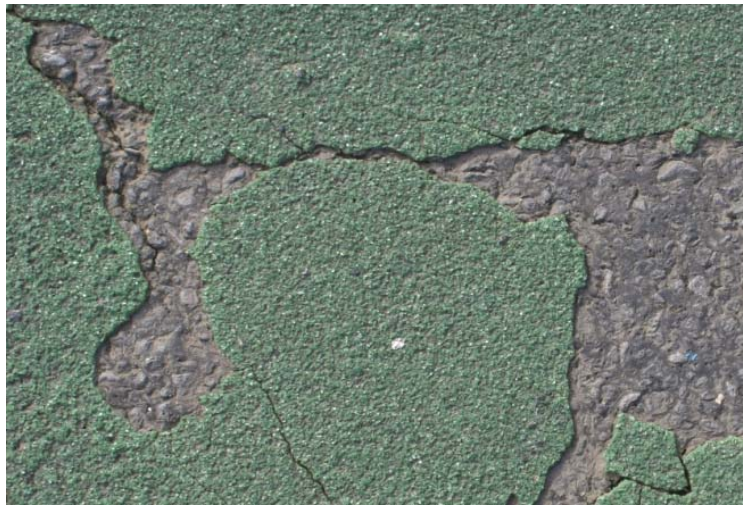
Coloured surfacings use similar binders without the CB chip so do not produce a high friction surface. These were included in the investigation to illustrate that some of the failure mechanisms are not solely caused by the high shear stress. Figure 4 shows a coloured surfacing delaminating from a bitumen rich chipseal surface on a cycle lane. The surface condition prevented the HFS from chemically and/or mechanically bonding to the aggregate on the existing surface.

Figure 4: Coloured surfacing delaminating.

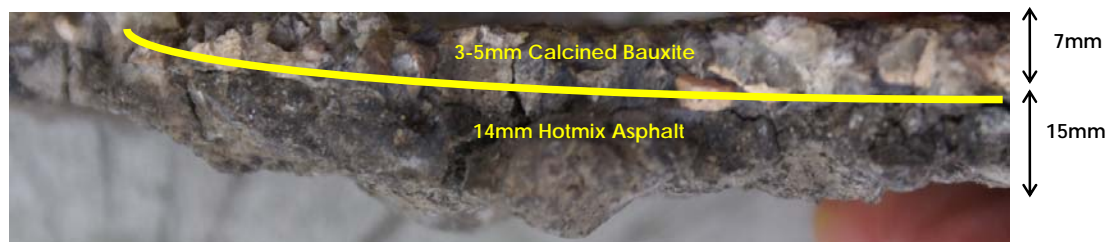
Currently the most common mode of failure of HFS surfacings in New Zealand is the cohesive failure in the substrate where the HFS is well bonded to the surface of the asphalt substrate and the HFS with the surface of the asphalt attached to it peels off (see Figure 5).

Figure 5: 3-5mm Calcined Bauxite with epoxy binder and surface of 14mm HMA

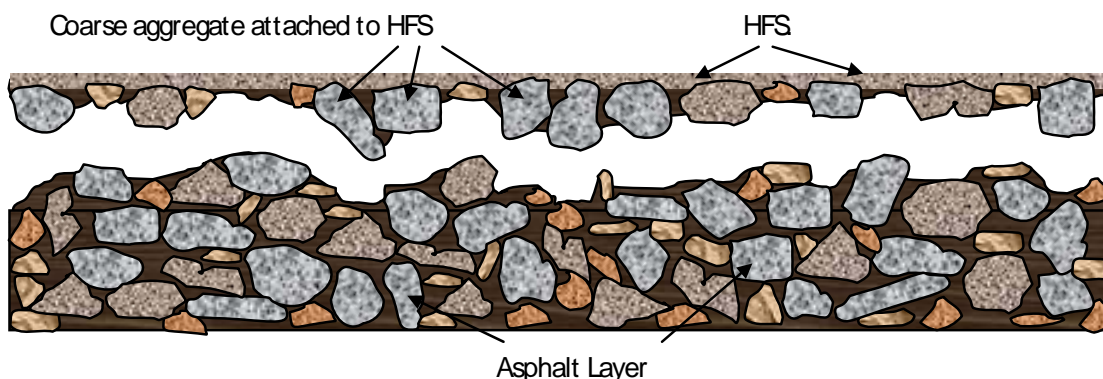
Figure 6 depicts the result of cohesive failure within the HMA, this diagram shows clean aggregate and could represent a failure caused by stripping of binder from the coarse aggregate.

Figure 6: Diagram depicting cohesive failure.
