Re-use of High Skid Resistance Aggregates in Porous Asphalt

Department of Civil and Environmental Engineering, The University of Auckland

5th International SaferRoads Conference | Auckland, New Zealand, May 21-24, 2017

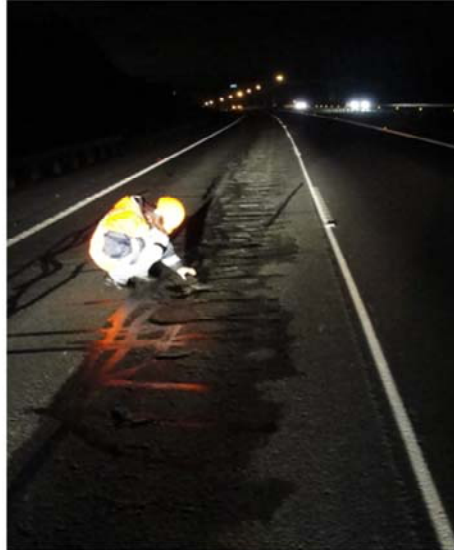
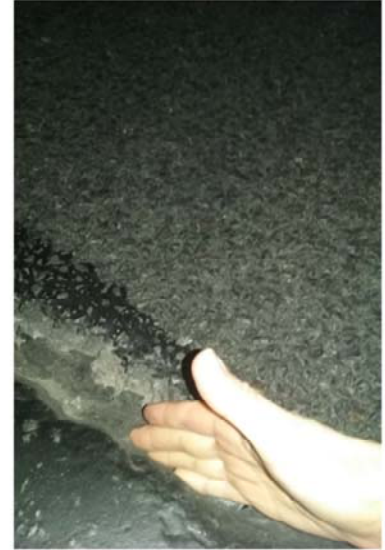
- 30 sites were visited (at night) over 1.5 years
- Each site was photographed and information recorded
- Majority of sites visited had issues with base failures

Field visits to around 30 sites over 1.5 years were carried out on the Auckland motorway network. Each site was photographed, failure modes recorded and site information collected. It was evident that the majority of PA sites visited had base failures, some to the point of significant pavement deterioration. However, it is important not to generalize. This observation about numerous base failures only relates to the sites visited. Despite this, it is important to note that the site selection was not specifically targeting sites with base failures. It was based on the suitability of site for visiting such as selecting sites where safe to visit during closures for maintenance work. These sites also cover a wide range of locations of Auckland motorways network.

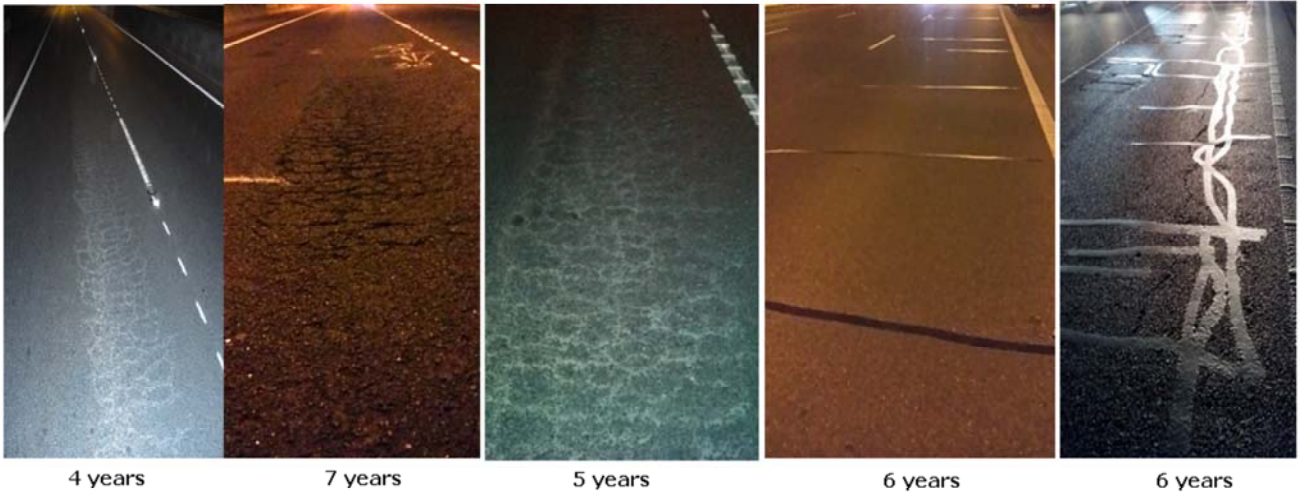
Based on the data collected, sites as young as 4 years old were milled and replaced due to the issues with bases. PA itself on such sites was in excellent condition.

The majority of the sites milled were around 7 years old. However, in the most cases the issue was base failures, not PA itself.

Cracking, fines pumping, pavement sinking, potholing and corrugation were amongst the commonly observed issues during the site visits. Some sites had aggregate disintegration in the PA mat.

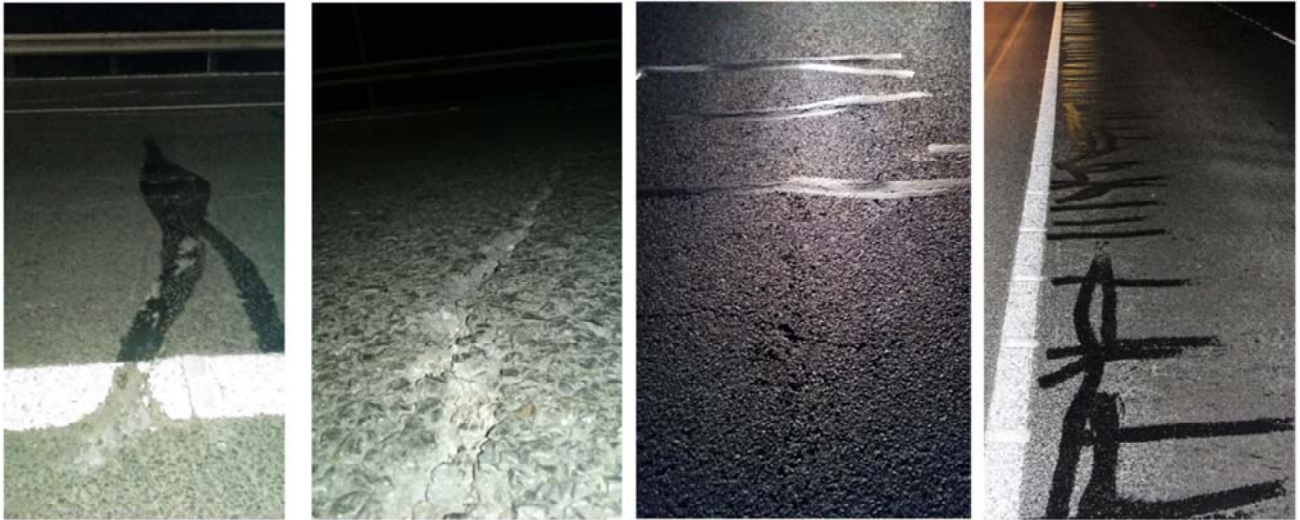
Examples of the most common base failures observed on Auckland motorways

These are the most common failures observed on PA sites. Especially regular interval cracks in a form of the fork with two prongs were present.

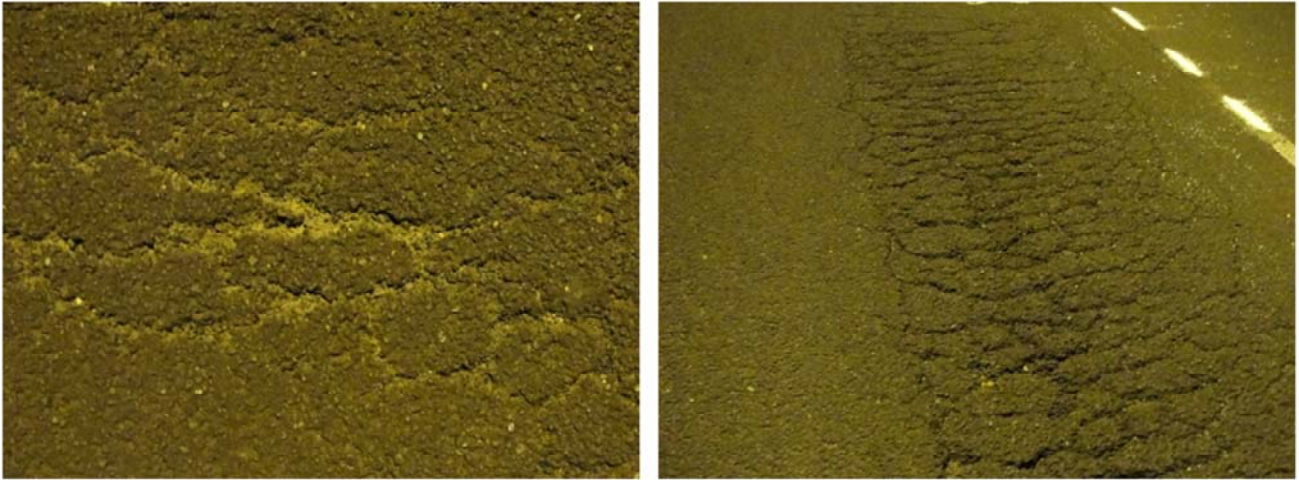
PA with melter slag. 6 years old. PA mix itself was in a good condition

On this site, the melter slag aggregate was utilized. It was only 6 years old site, but it has severe cracking and fatigue failure. The PA itself was in a good condition. This meant that the valuable melter slag aggregate was not able to provide the long term benefits to the PA possible.

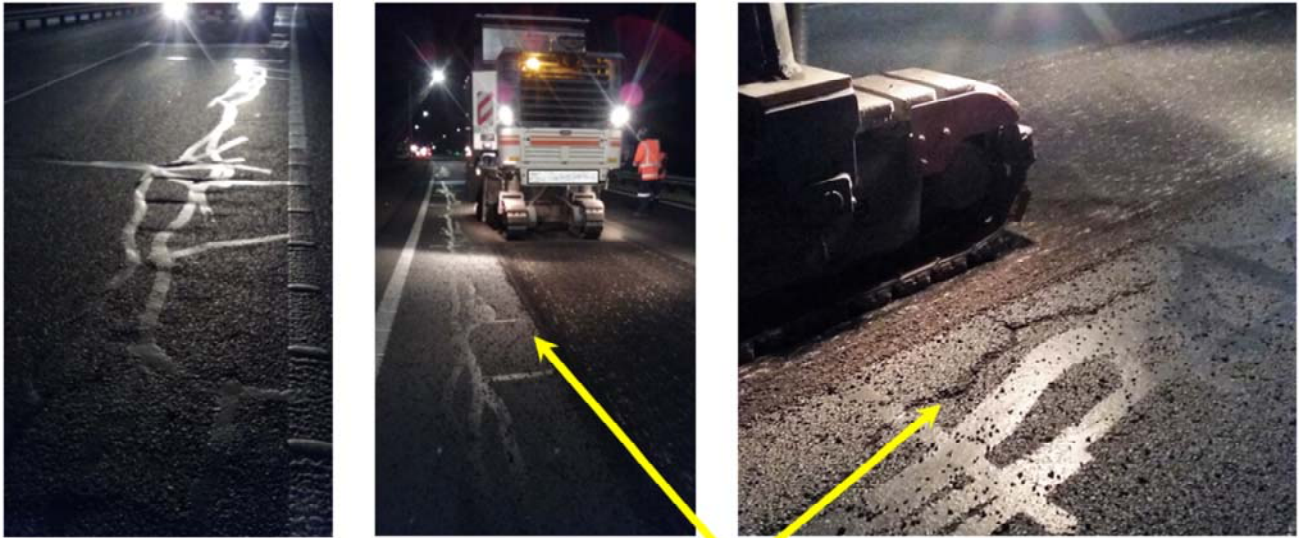
Deep cracks > 25 mm milling depth

Some cracks were significantly deeper than the milling depth. This slide also demonstrates how much crack sealer gets incorporated into the millings, so it becomes a part of reclaimed asphalt pavement (RAP). The amount of crack sealer applied on each site would vary, so it is one of variable which needs to be understood for recycling of PA RAP. This crack sealer is mostly recycled tyre rubber based sealer.

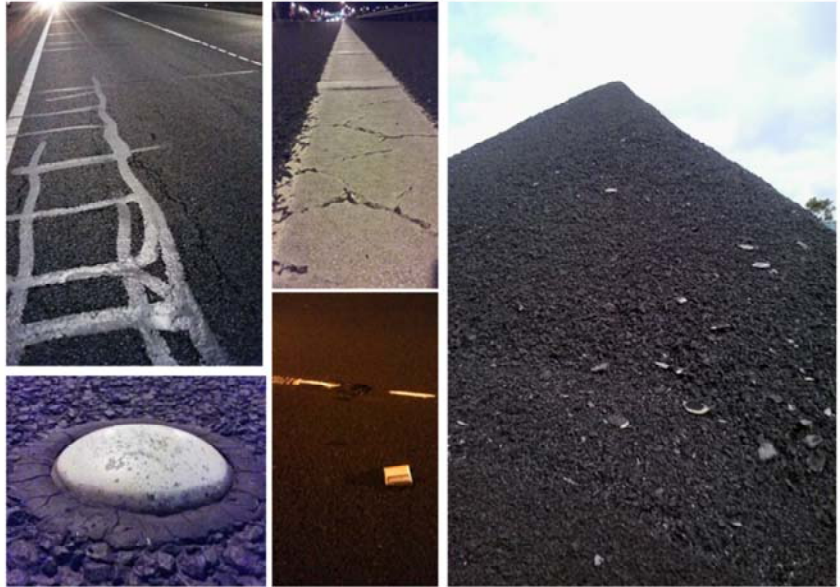
- crack filler
- cold applied plastic (CAP)
- retro reflective pavement marker (RRPM, cat eyes)
- road shoulder materials

RAP can have various contaminants which can affect recyclability of this material. This includes crack filler, cold applied plastic (CAP), retro reflective pavement marker (RRPM, cat eyes) and road shoulder materials.

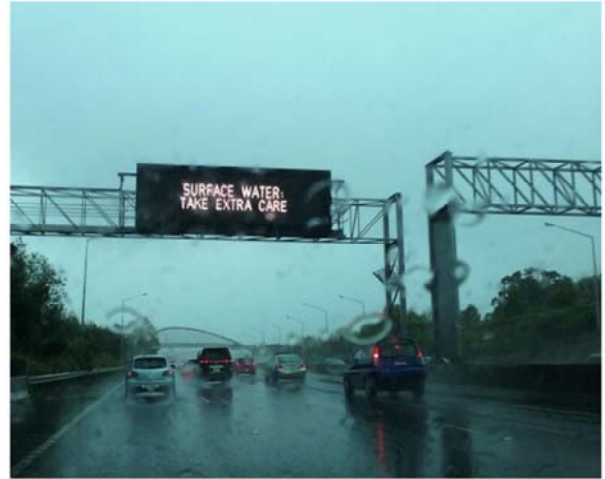
Clogged PA in rain on Auckland Motorway

PA get clogged over time. No cleaning of PA is carried out in NZ compared to, for example, the Netherlands or Japan, where PA is regularly vacuumed to maintain drainage properties and provide the maximum safety benefits.
