RESULTS OF PHYSICAL WORKSHOP
1st Australian Runway and Roads Friction Testing Workshop

John Dardano B.E (Civil), M.Eng.Mgt

August 2003

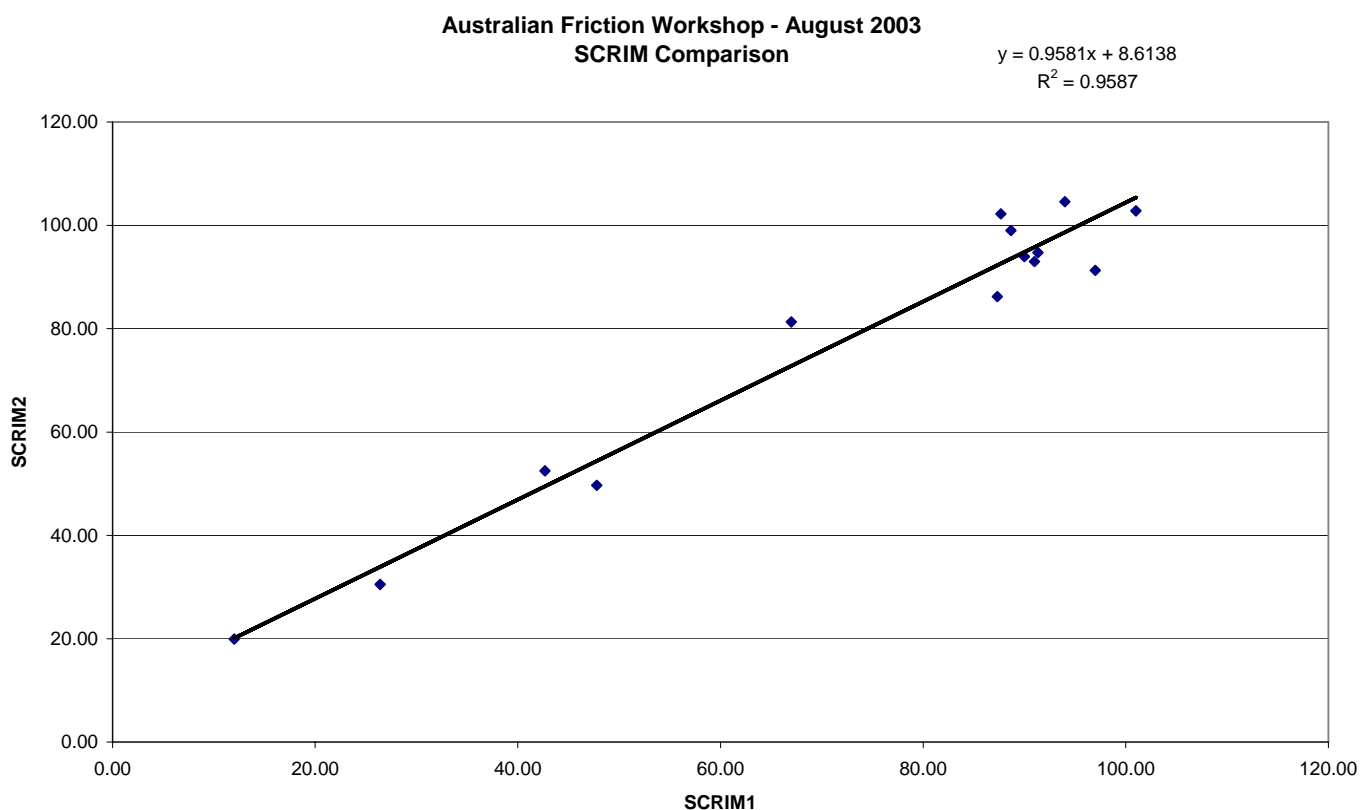
Comparing the two SCRIMs through a harmonisation analysis, the correlation co-efficient (R^2) is 0.96. This indicates that the two SCRIMs correlate quite well.

However, what can not be stated is whether the differences between the two machines was due to variability of testing or whether one of the devices was slightly out of calibration.

- A. Whilst both SCRIMs showed an increase in recorded friction from the smooth concrete test surface (C-1) to the grooved smooth concrete test surface (C-2), neither SCRIM showed much of a change between the broom grooved and un-grooved concrete surfaces.
- B. Both SCRIMs showed a reduction in friction values for all of the rejuvenation surface treatments, R-1, R-2 and R-3.
- C. There was significant variability on the slurry seal surfaces. However, this is in line with the visual inspections, which indicated that the surfaces were not homogeneous.

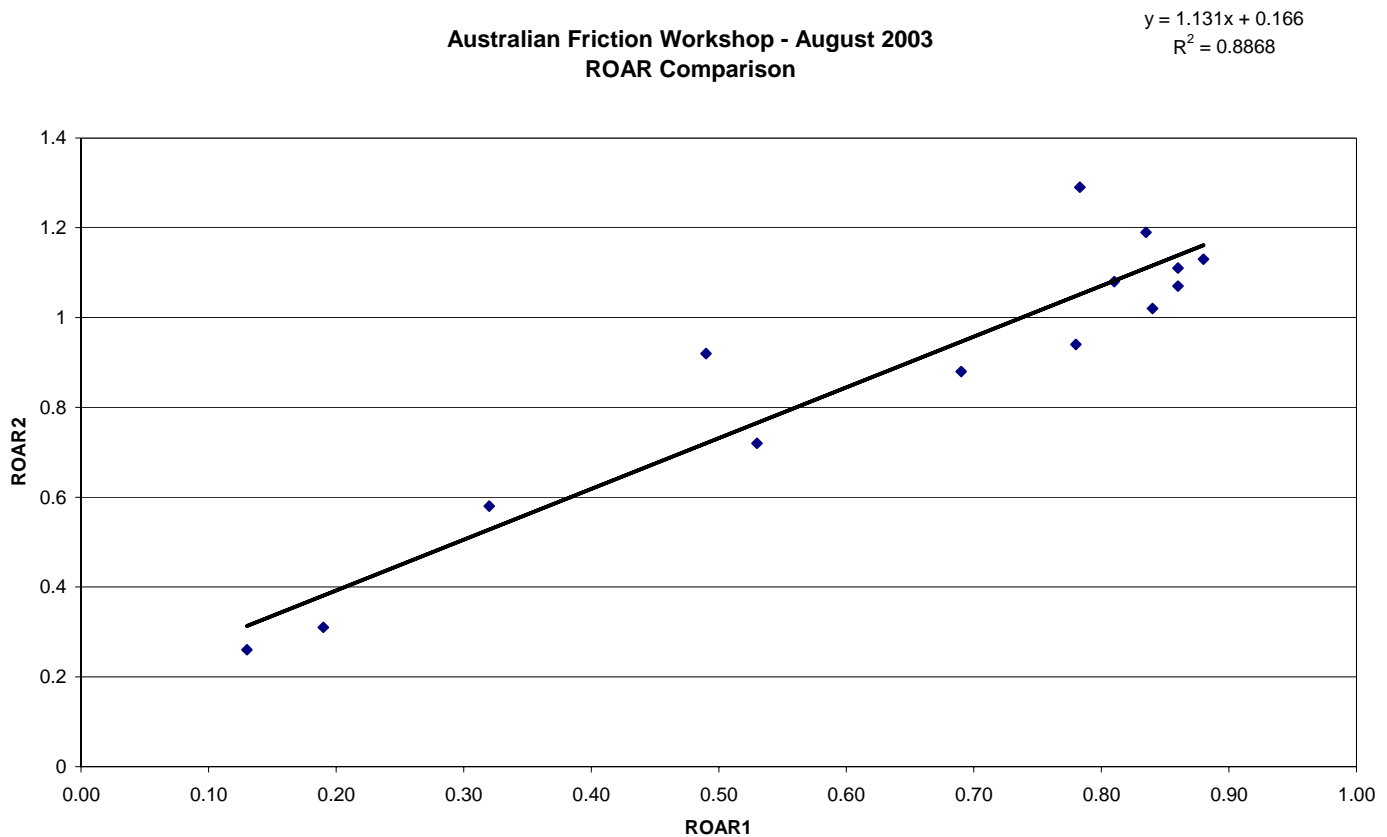
Comparing the two ROARs through a harmonisation analysis, the correlation co-efficient (R^2) is 0.88. This indicates that the two ROARs did not correlate well. If you remove two surfaces from the analysis, C-2 and C-3, then the correlation co-efficient (R^2) increases to 0.97 which is a high value.

However, C-2 or C-3 where not on the same track and where tested several times by both machines. As such, it would be difficult to question the result on these two stable surfaces.

- A. The average variability between the two ROAR's was 30%.
- B. Both ROARs showed a reduction in friction values for all of the rejuvenation surface treatments, R-1, R-2 and R-3.
- C. Whilst both ROARs showed an increase in recorded friction from the smooth concrete test surface (C-1) to the grooved smooth concrete test surface (C-2), ROAR1 showed only a small change between the broom grooved and un-grooved concrete surfaces (C-3 and C-4), whilst ROAR2 showed grooving reduced the result.

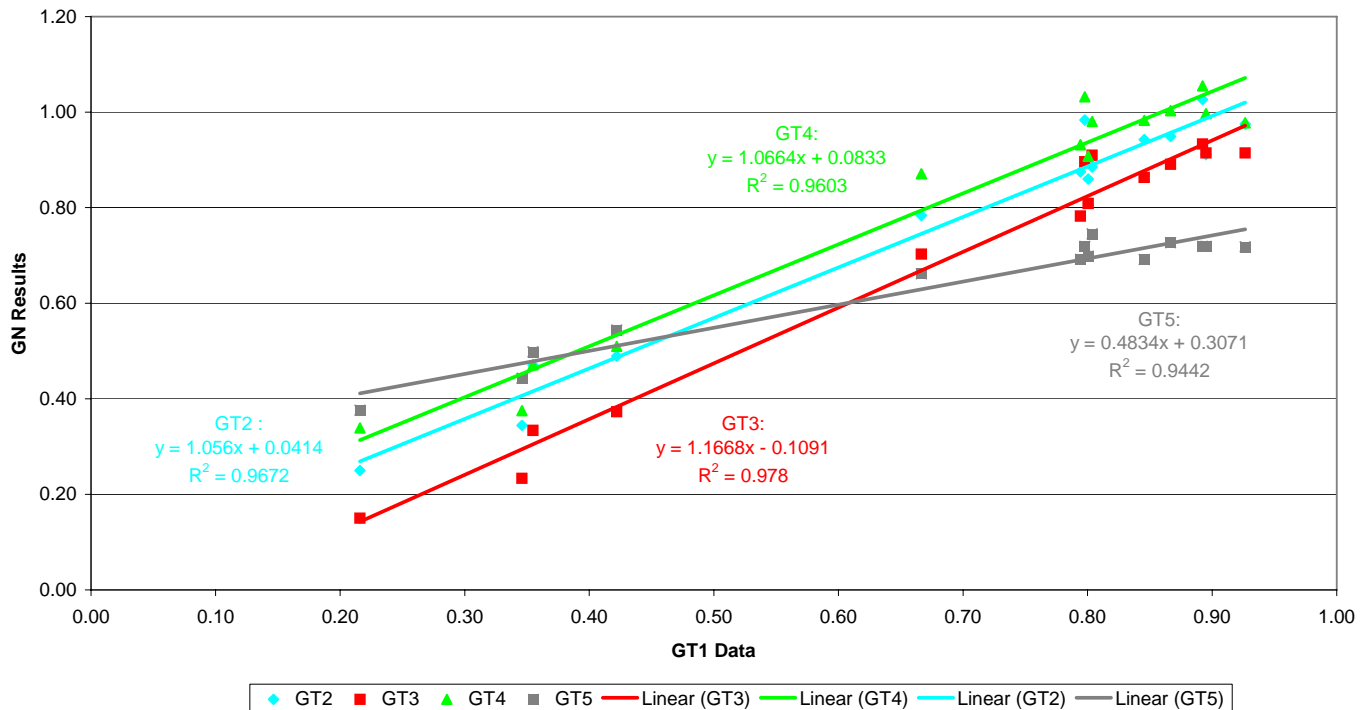
Australian Friction Workshop - August 2003
GripTester Comparison

Using GT1 as the reference device and comparing the GripTesters through a harmonisation analysis, the correlation co-efficient (R^2) for all devices was greater than 0.94. This indicates that all the GripTesters correlated well against the reference device.

However, GT5 was obviously experiencing technical problems as the harmonisation constants are so large and the grade of the line varies significantly from the other devices.

- A. The average variability between all five GT's was 17%. If GT5 is excluded from the analysis this average variability is reduced to 9%
- B. All GTs showed a reduction in friction values for the rejuvenation surface treatments, R-1 and R-3, but minimal reduction of R-2. This illustrates the sensitivity of the GripTester to microtexture.

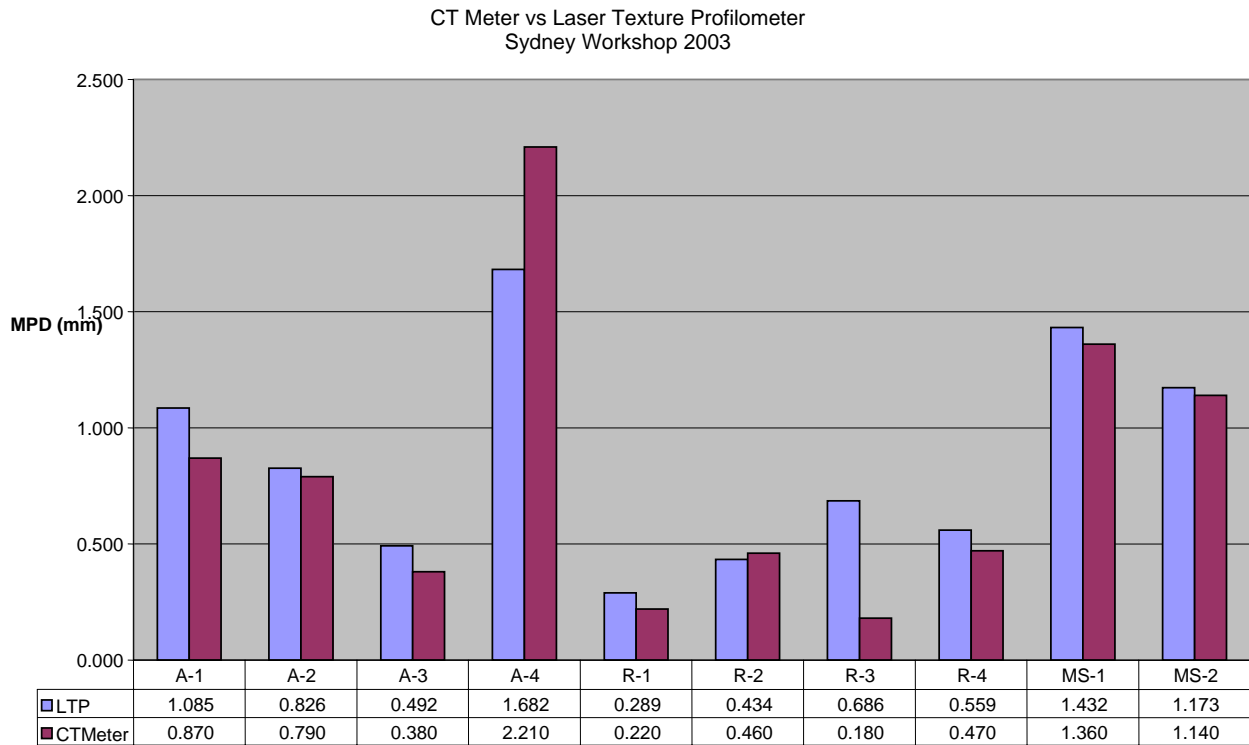
Both the CT Meter and the Laser Texture Profilometer calculate Mean Profile Depth (MPD). The results of each methodology are compared below.

Of the ten test pavements, two surfaces (MS-1 and MS-2) showed high degree of variability. The Cold Overlay test pavements were constructed one month before the workshop and were unfortunately too "green". Visual inspections confirmed that they were highly variable.

As such it would not be fair to compare the results of the CT Meter and the LTP on these pavements, even though the variance between the CT Meter and the LTP was only 4.1%.

What is not easily explainable are the differences between the two devices on the Asphalt and Rejuvenation surfaces, outlined in Table 7.

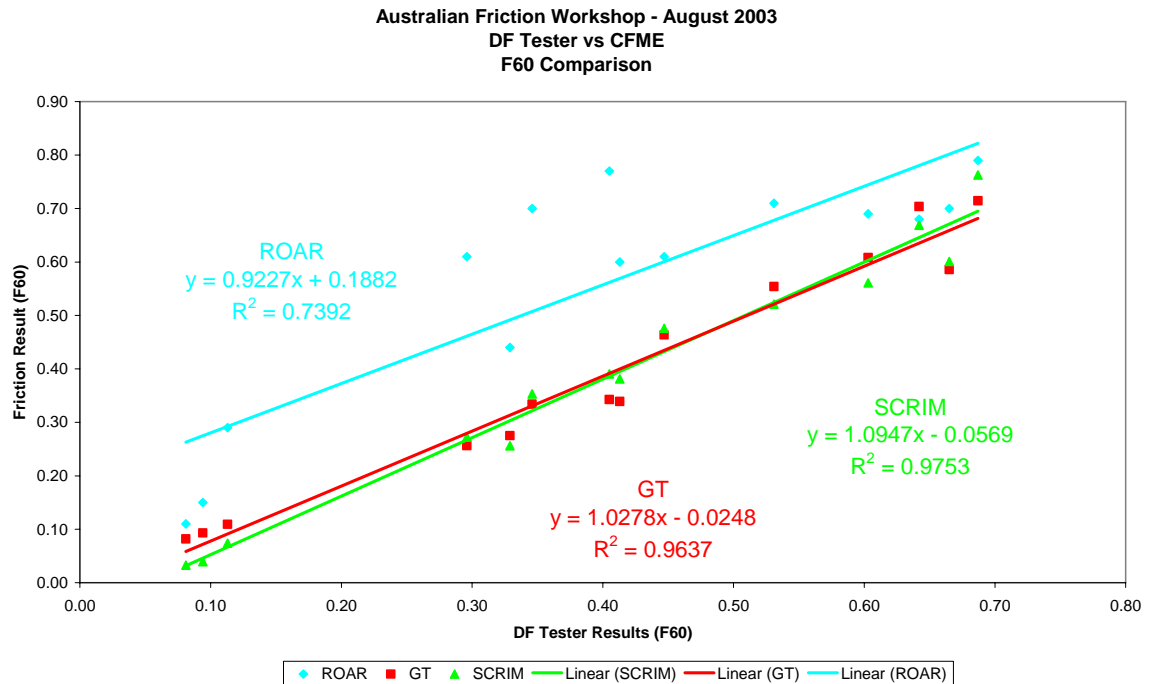
When comparing the data, the DF Tester, GripTester and the SCRIM all correlate extremely well.

However, the ROAR has an R^2 value of 0.74 which is low and does not appear to have good correlation. This can partially be explained in that the test pavements were short (100 metres) and the device was running in variable slip mode.

- D. When ASTM 1960 was used to convert CFME data to F60, the SCRIM, GripTester and DF Tester showed excellent correlation. However, the ROAR did not show good correlation which could have been due to the device working in variable slip mode.

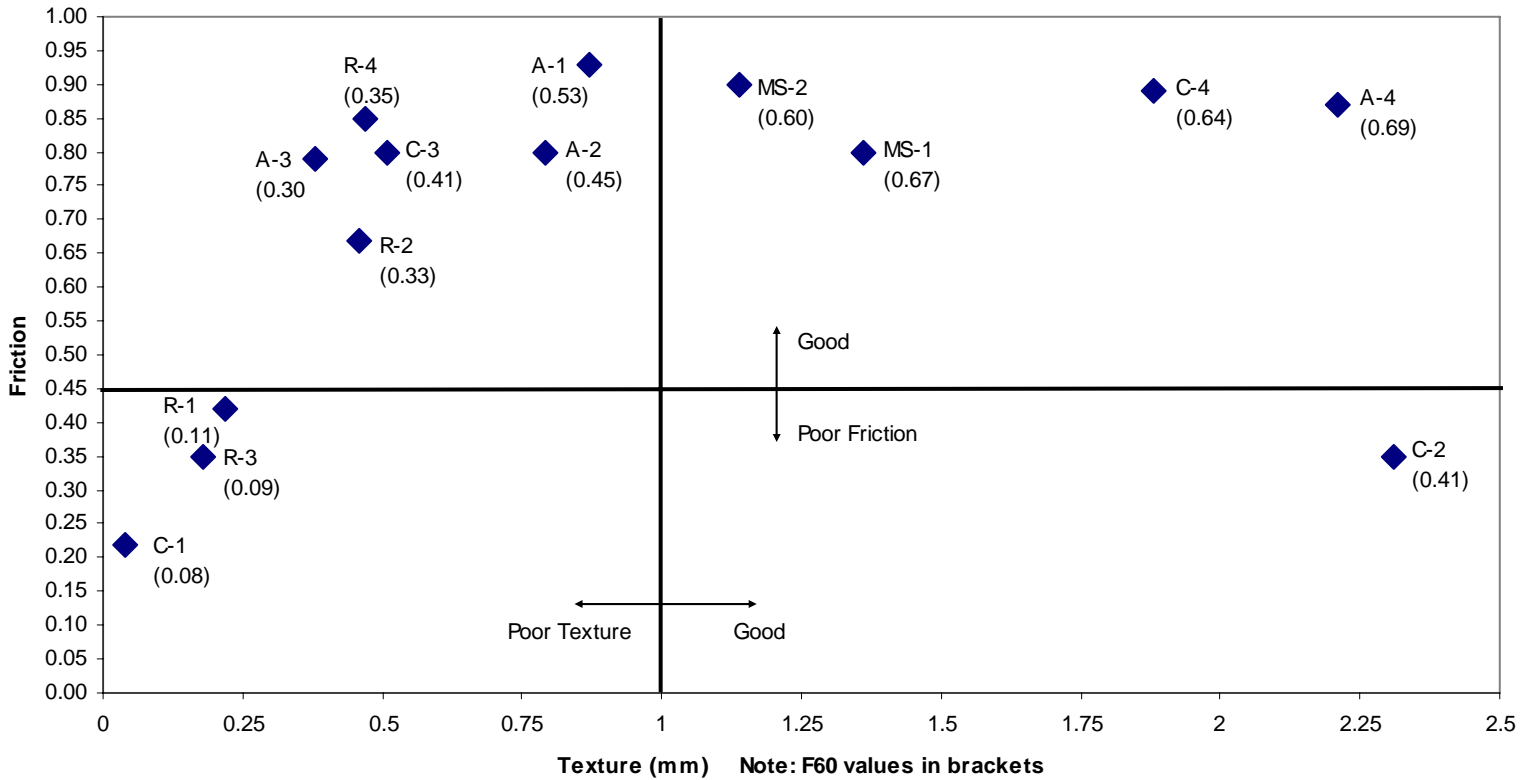
Sydney Workshop - August 2003
Texture vs Friction vs F60

The results are then graphically displayed below. The area of the graph is divided into good friction (>0.45) and poor friction and good texture (>1 mm) and poor texture.

- Test Pavement C-2 has good texture but poor friction. This is in line with expected results as the surface is polished.
- The grooved test pavements have the highest texture and friction and have good F60 results.
- The polished concrete has low texture and poor F60 in line with expected results.
- The stone mastic asphalts produced a poor texture and F60 result

- E. Texture and Friction independently are inadequate measures to correctly determine the characteristics of a surface. F60 as a concept for combining texture and friction did provide a suitable parameter to classify a pavement's characteristics.

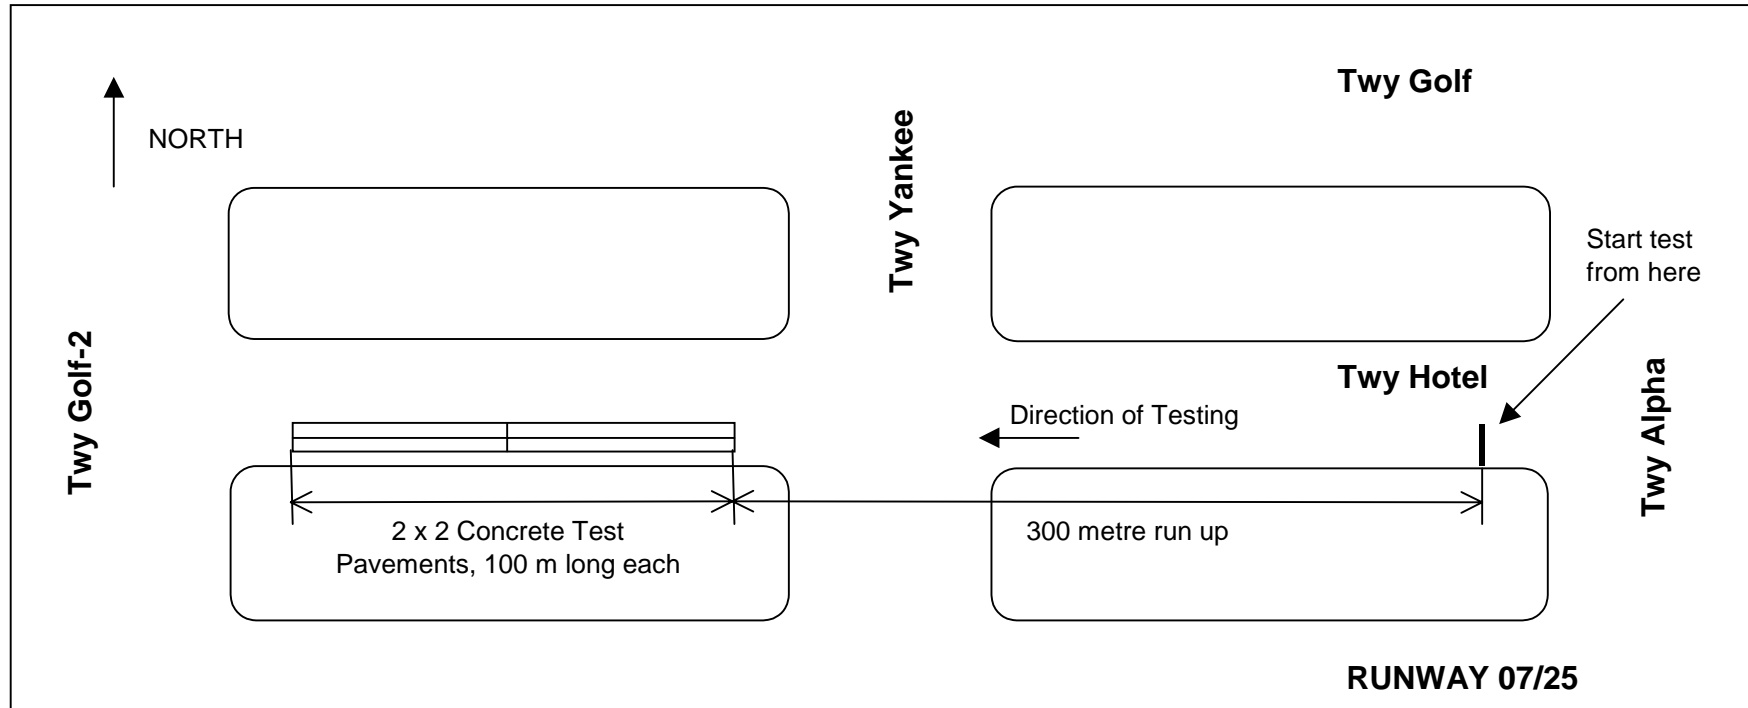
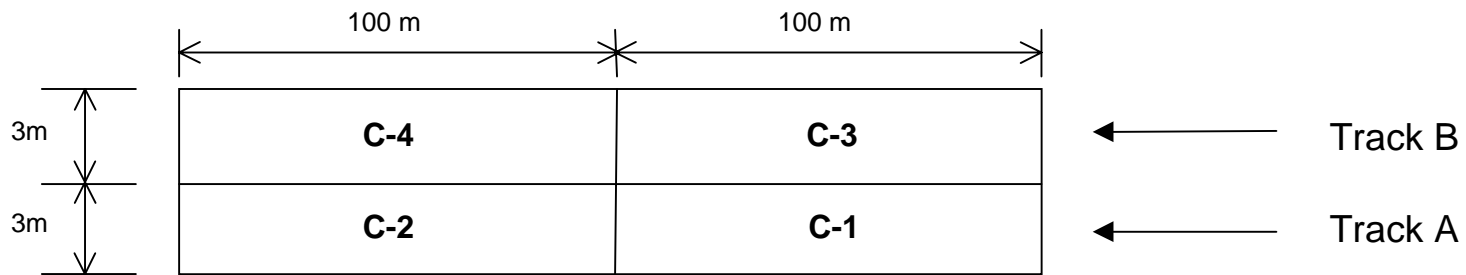
SITE B : TAXIWAY HOTEL

Schematic Diagram of Site B
