Alleviating the Skid Resistance Problem - The Israeli Experience

Yaron R. and Nesichi S.

Aram Engineers – Haifa Israel, Public Works Department - Israel

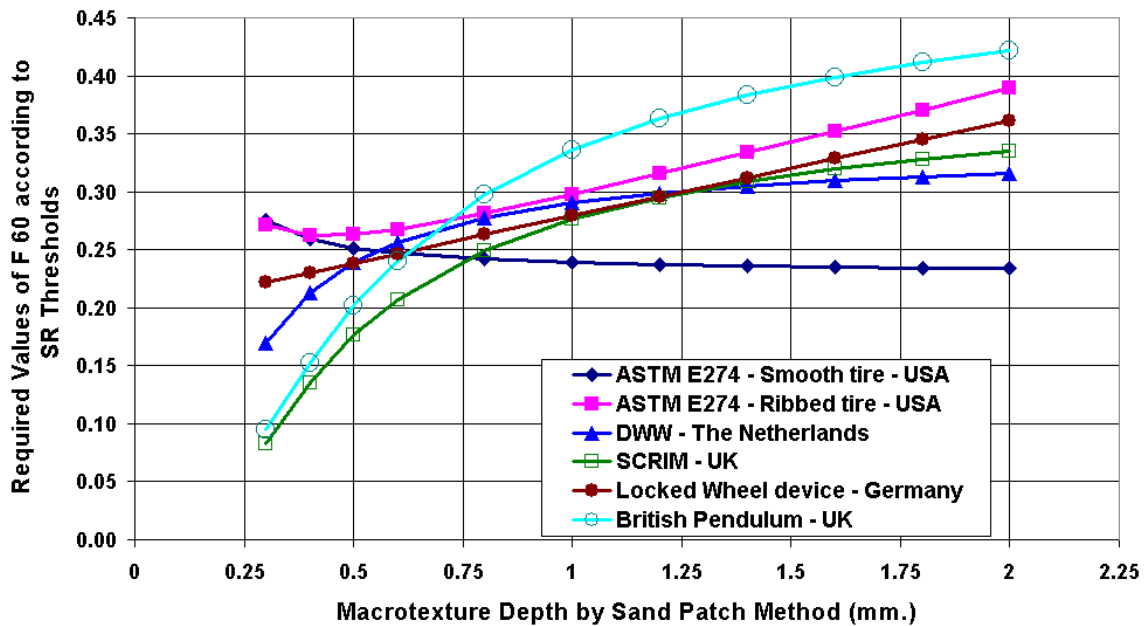
Figure 3 summarizes the results of the above analysis. For example, a surface having SR value of 50 BPN (an average threshold value, slightly under the recommended value for major highways in UK and the value required in Switzerland for highways, Ref. 10) has a good F60 value if the macrotexture depth is 2-mm, but a very poor F60 value, if the macrotexture depth is about 0.4-mm. It should be noted that similar behavior characterizes all low velocity SR testing devices. The picture as a whole depicts, for each value of macrotexture depth, the range of minimum F60 that is needed in order to provide adequate skid resistance.

**Figure 3: Required values of F60 according SR thresholds
vs. Macrotexture Depth**

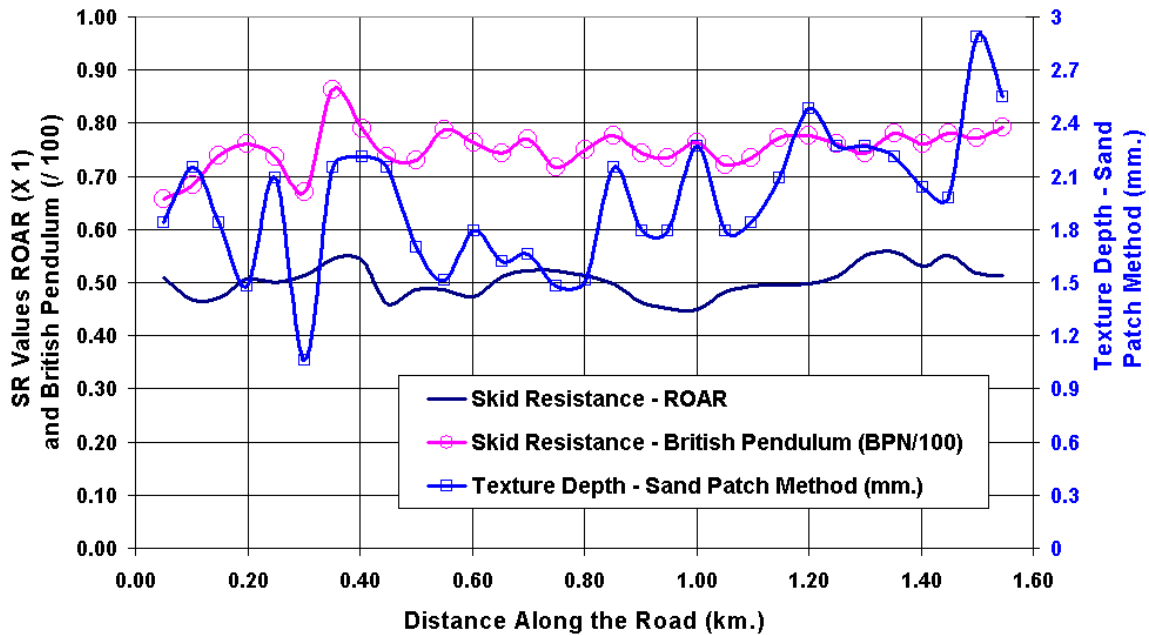
Figure 4 depicts the results of one of the test sections. The values represent the average of 4 consecutive runs with the ROAR and 30 British pendulum test points along the 1500 meter section. Additional 30 tests of texture depth were conducted by the Sand Patch method.

Figure 4: Results of SR measurements at a test section – Road no. 806

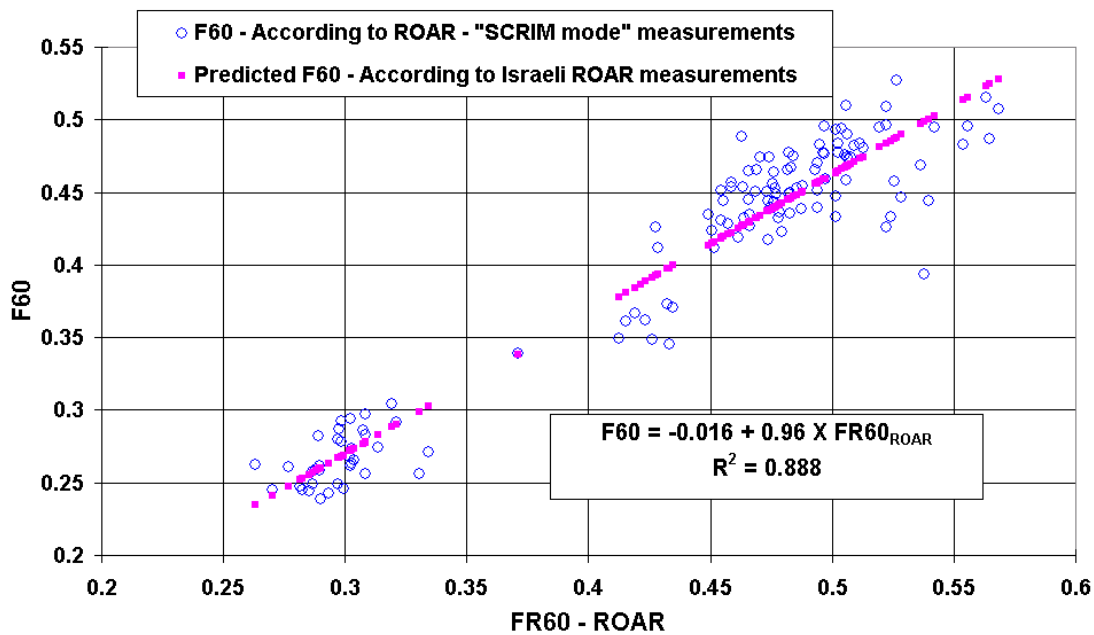
Figure 7 shows the distribution of the results. The R² of the results is 0.88, better than the result obtained with the British Pendulum.

Figure 7: Distribution of results – IFI constants of the ROAR through indirect regression process with the SCRIM

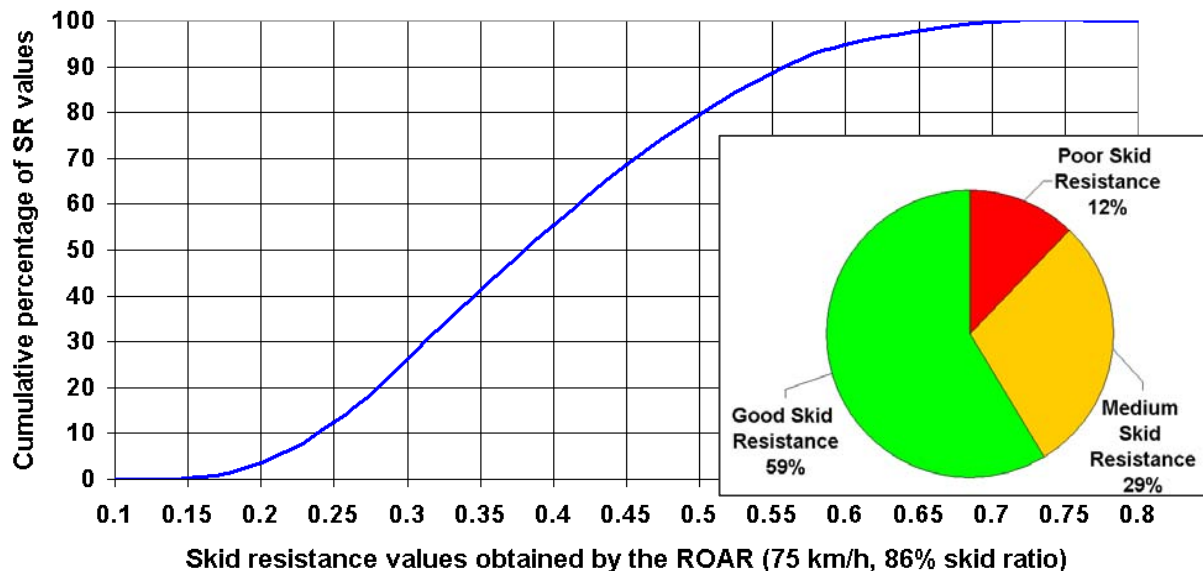
Figure 9 depicts the general results obtained in the survey. The results show that about 12% of the road network has substandard skid resistance and has to be treated. About 29% have medium values of skid resistance, in the range of 0.25 to 0.35. In the cumulative representation of the results it can be seen that if the threshold was set on 0.30, about 28% of the road network would be labeled as substandard.

Figure 9: Summary results of the general 2003 winter-spring survey

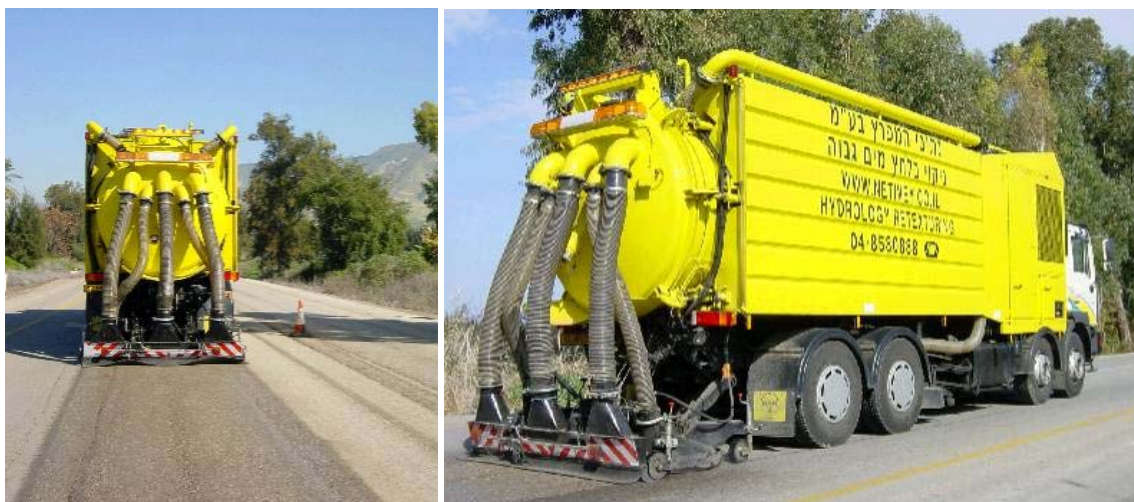
Figure 11 depicts pictures of one of the water blasting trucks that presently work in Israel. The truck has large containers for fresh water and for “used” water that was vacuumed from the road surface during the working process.

Figure 11: General view of a water blasting truck that works in Israel

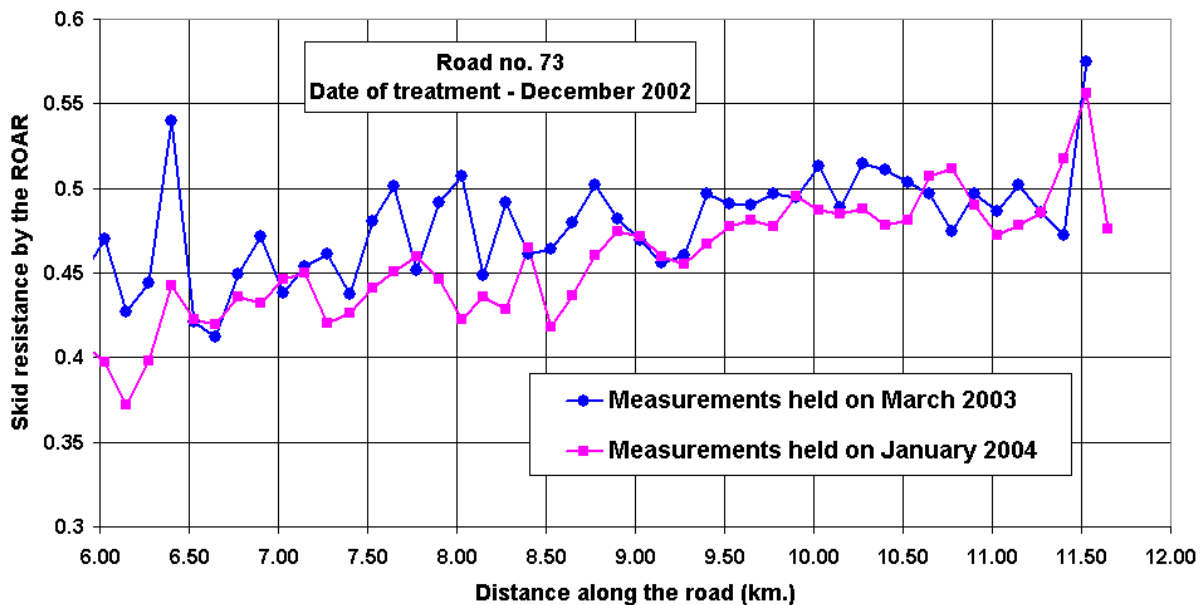
- A. The method can be successfully used for the improvement of asphalt mixtures that are based on a strong “skeleton” of coarse aggregates. In such mixtures, like the SMA, or SHRP based mixtures. The process is very efficient in removing excess quantities of bitumen (a common problem with SMA mixtures) and restoring the original texture depth. Figure 12 shows an example of a road section treated by water retexturing on December 2002 due to inadequate levels of SR. The wearing course is $\frac{3}{4}$ ” SHRP type basaltic asphalt mixture. As can be seen, the SR values remain high more than a year after the treatment and according to the rate of SR degradation, another treatment is not necessary for at least another year.

Figure 12: Skid resistance results on a road section treated with water retexturing

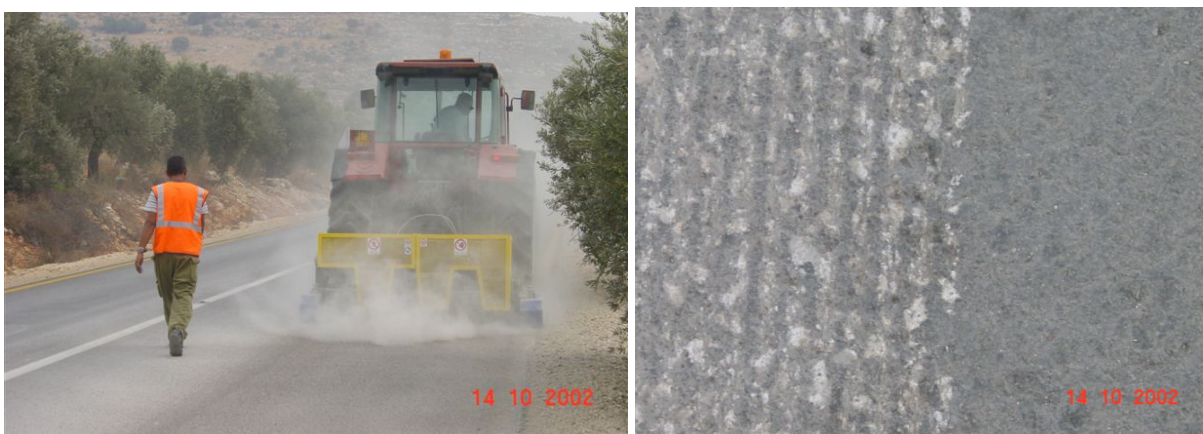
As with the fine milling, a mechanical broom should follow the retexturing machines, in order to clean the pavement. However, the amounts of material that are removed from the surface are much smaller, usually no more than 2-3 mm. Figure 16 shows an example the working process and the attained surface of the road.

Figure 16: The Rotating Discs process at work and the attained surface

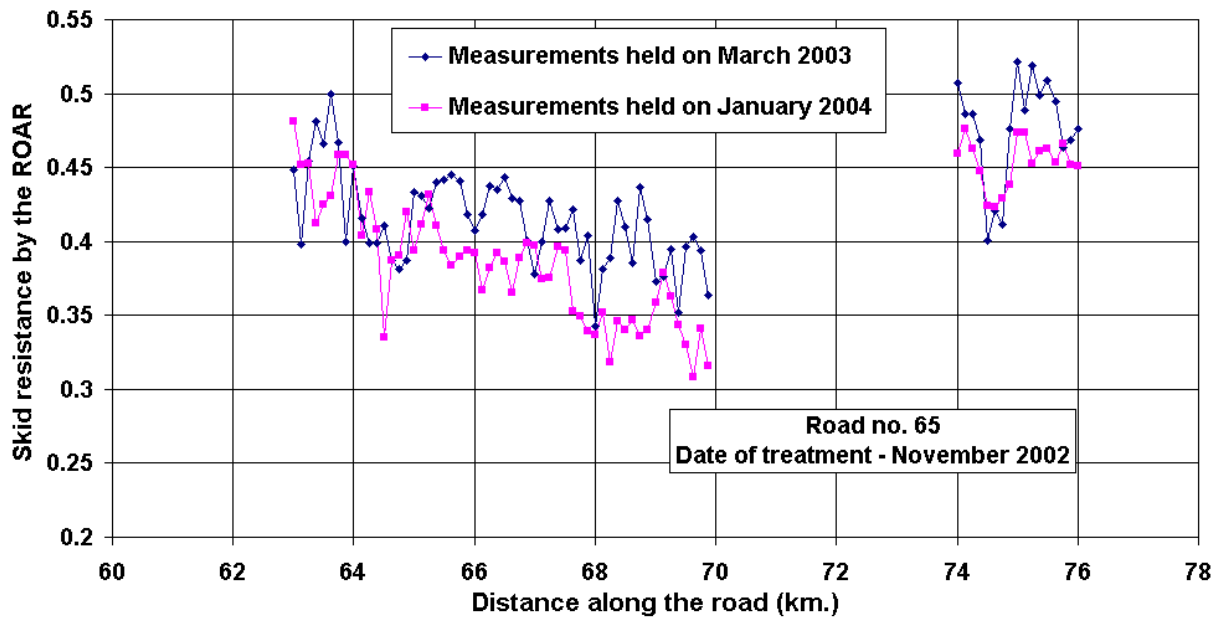
milling. Figure 17 depicts an example of SR results of a treated road section, having a densely graded 1" Dolomitic wearing course.

Figure 17: Skid resistance results on a road section treated with the Rotating Discs method
