DEADLY WHEN WET – A SERIES OF CASE STUDIES

David R Axup, David R Axup & Associates, Australia

ABSTRACT

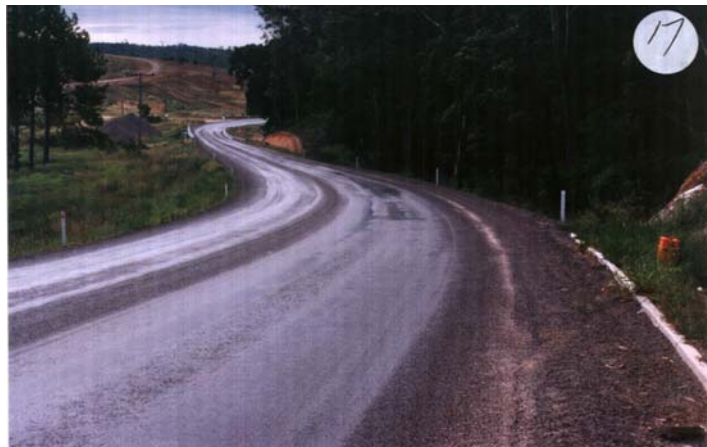
Figure 2: The D'Aguilar Highway, Queensland. Dry, as shown, 0.7. Wet 0.16

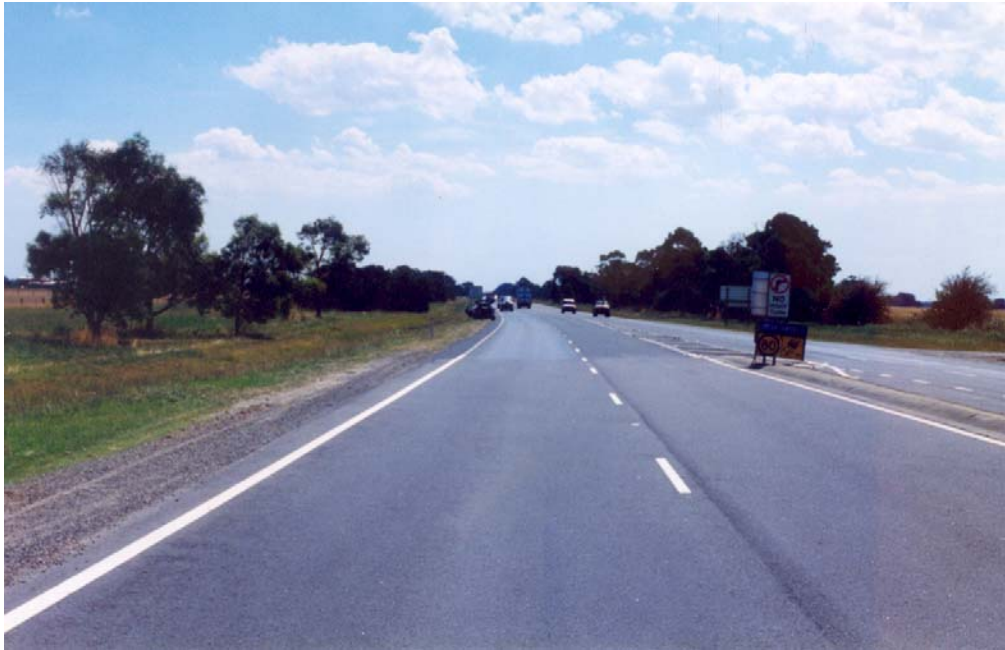
Figure 4: The section of road involved. Note the change in surface and the difference between the left and right lanes beyond the change.

Skid testing was undertaken on the wet road by the Victoria Police Major Collision Investigation Unit and the result for the left lane obtained in a Commodore sedan with standard tyres was $f = 0.34$ and when adjusted for a truck tyre $f = 0.255$.

Less than a month later a small tourist bus returning from Phillip Island went out of control and capsized at the same location. Fortunately injuries were minor however it caused such a political storm that remedial treatment of the road was immediately put in place.

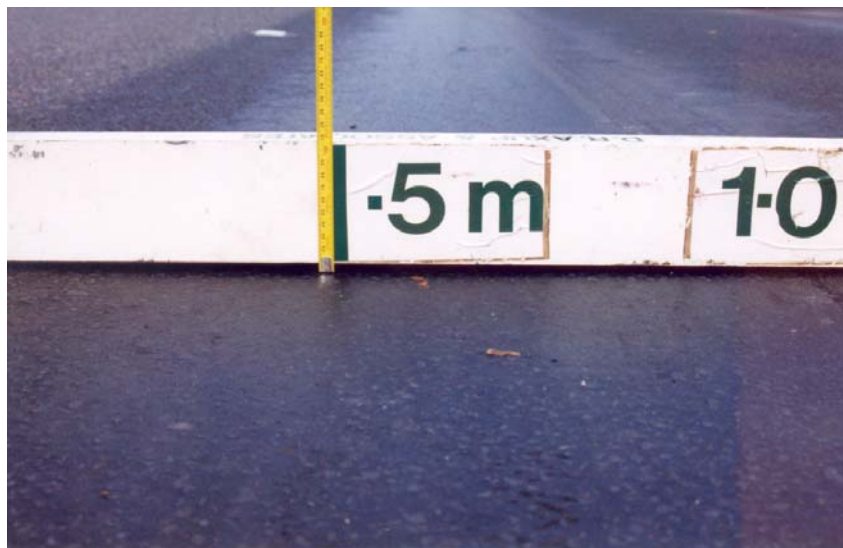
Figure 5: Rutting and flushing in the left hand lane

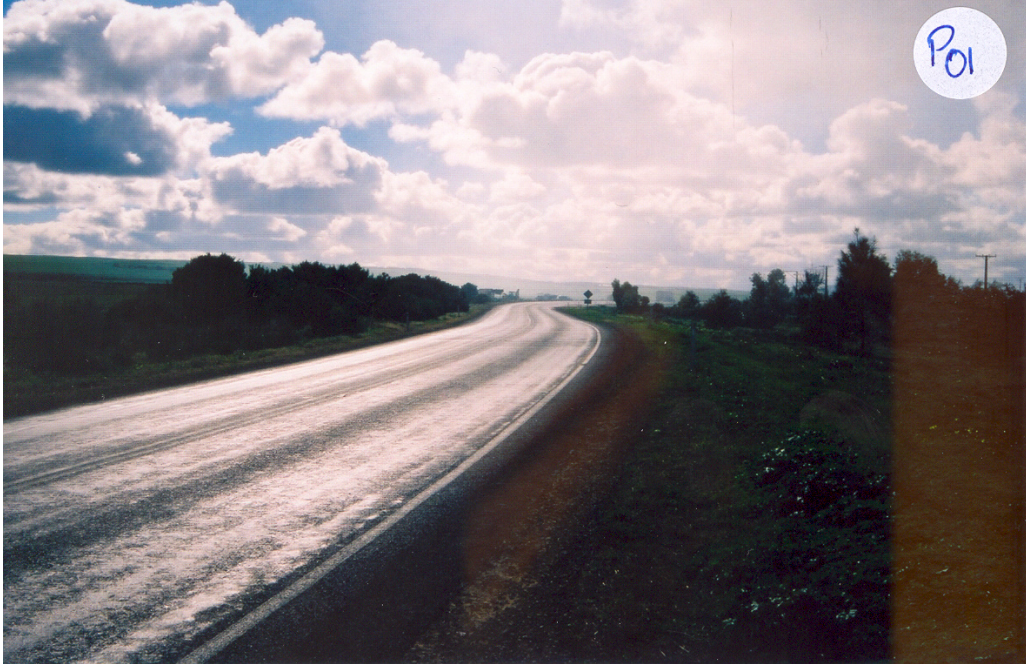
Figure 6: The highway in question looking back along the approach path of the errant vehicle

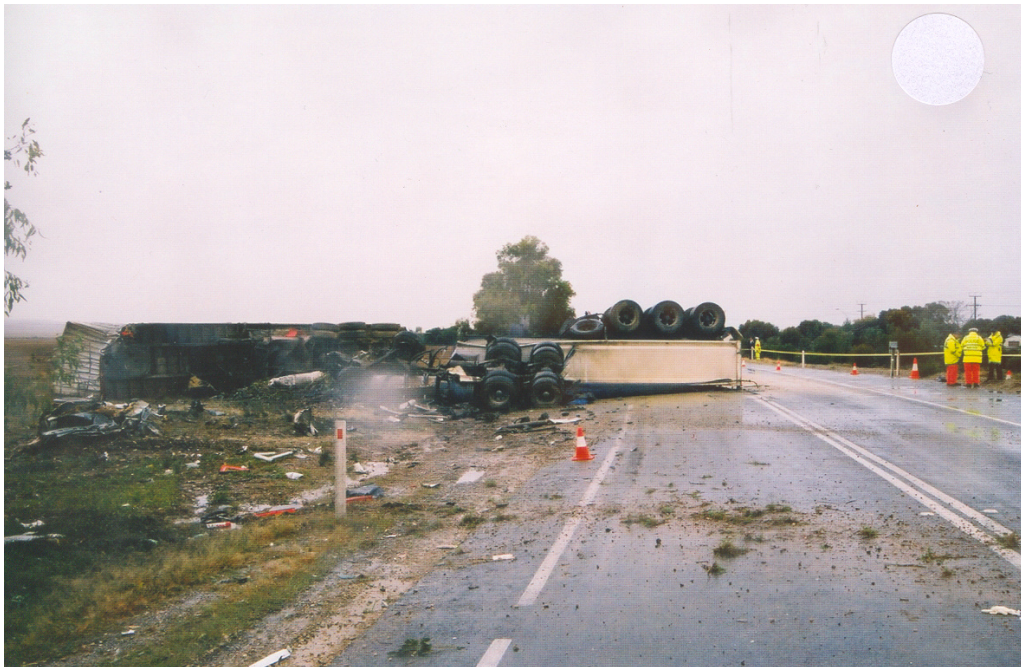
Figure 7: The collision scene.

The angle of first contact between the two vehicles was determined from the physical evidence left by their post impact directions of travel compared to their pre impact directions. The rapid change of direction of the “loss of control” vehicle was calculated to be approximately 45 degrees indicating a very rapid rotation clockwise of the prime mover. Neither driver had the time or distance to avoid a collision.
