Update on use of Glenbrook Melter Aggregate to improve skid resistance and seal lives in Hawke's Bay: A route case study

Laurence Harrow OPUS Research, Wellington Ken Holst NZ Transport Agency, Napier Dave Whitehead NZ Transport Agency, Wellington

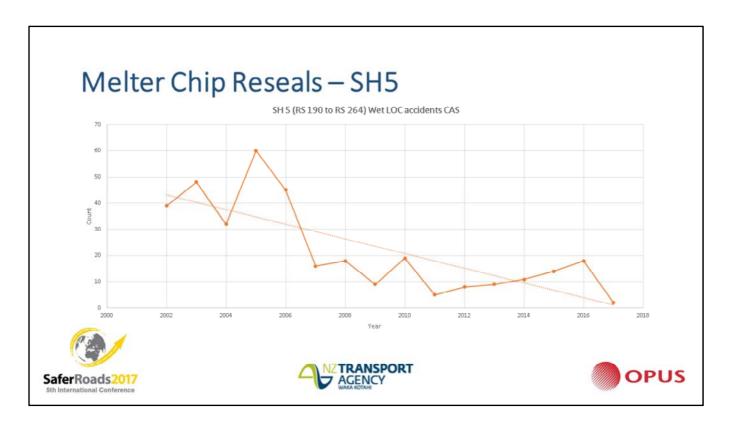
- 1. This graphs shows that there has been a significant drop in wet road LOC accidents on SH5.
- 2. We believe that this significant reduction is in part due to the progressive sealing of high demand skid sites with melter chip.
- 3. The introduction of the T10 skid resistance specification, completion of safety improvements, education, Policing and ABS will also have contributed to the reduction in wet road LOC accidents.

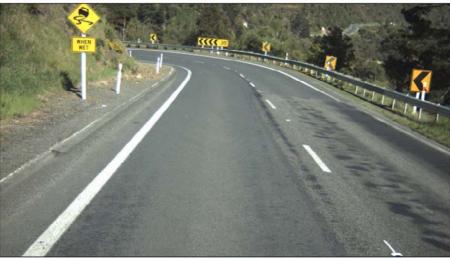
Case study 1: Tarawera Hill SH5 (RP 190/ 4.9 to 5.1)

- 1. This photograph taken from the November 2016 high speed data collection video gives some idea of the terrain and road alignment. There is a reasonable back drop of foliage beyond the curve and signage highlighting the curve and advisory sign of a slippery road surface when wet.
- 2. However none of that helps when you are travelling too quickly and need to brake heavily to negotiate the very tight curve ahead and the surface is providing very little in the way of skid resistance.
- 3. The melter chip seal was almost 7 years old when this photograph was taken. Visually it appears to be performing well for northbound traffic.

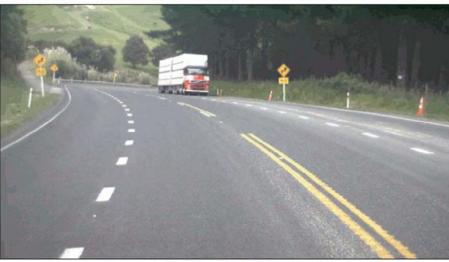
Case study 2: Waikare Gorge SH2 (RP 577/13.6 to 13.8)

- 1. This short video shows the gradient and curvilinear alignment of the site.
- 2. It also shows the slow vehicles bays for both the increasing and decreasing directions. It is possible that the south bound slow vehicle bay has increased the approach speed to the curve as motorists attempt to pass slow vehicles close to the end of the slow vehicle bay.
- 3. You can also see that the guard rail at the south end of the site on the RHS was extended to stop vehicles from ending up in the deep side drain.
