CYCLOPATH

In this presentation I will describe the development and use of a vehicle dedicated to the measurement of the infrastructure on both traffic free dedicated cycle paths and on road routes.

What we designed and how it answers the requirements

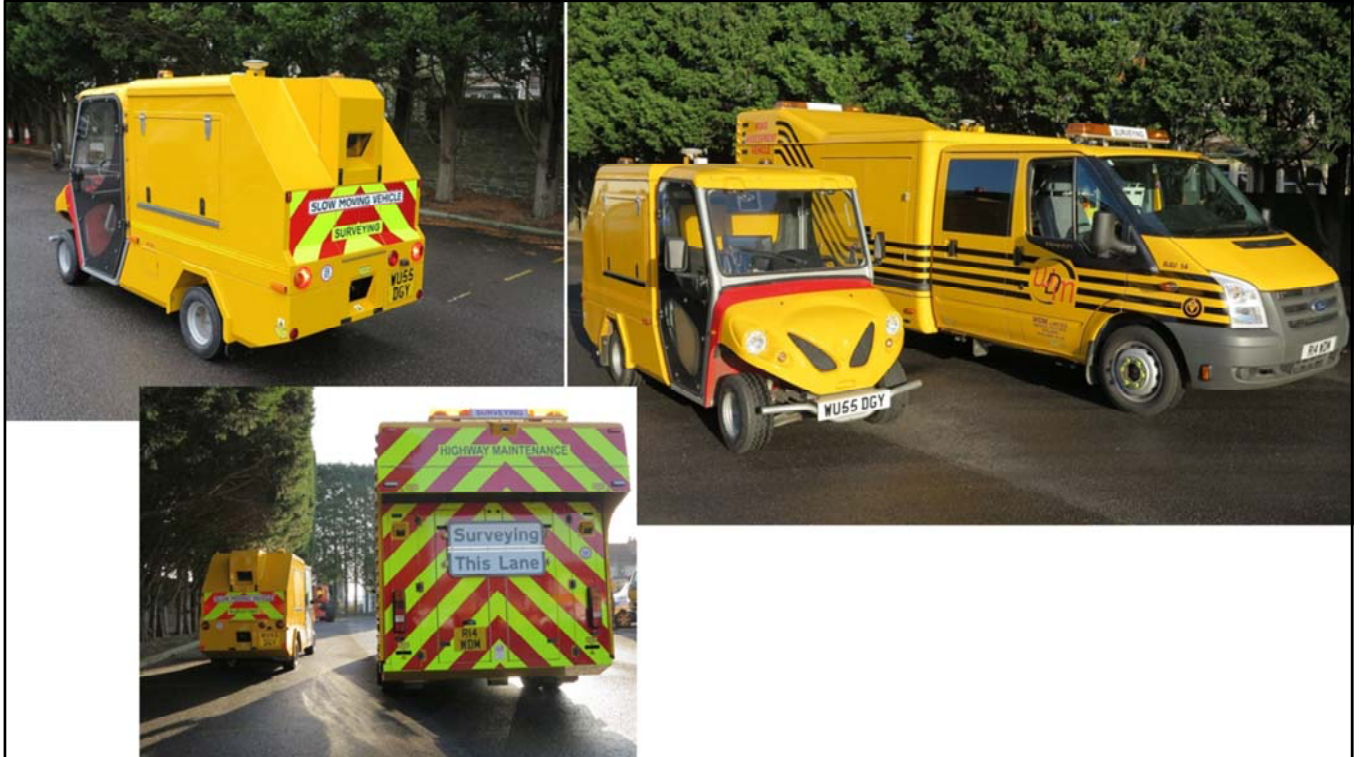
Size chosen to reflect the narrow nature of cycle ways

This shows comparison with one of our conventional high speed data collection vehicles or Road Assessment Vehicles, RAV's.

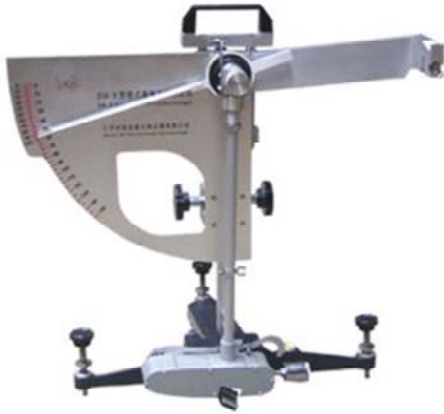
For dedicated routes material testing using the British pendulum

On traffic free routes, there is unlikely to be long term changes in skid resistance and so rather than regular monitoring, what is required is a robust approval system for the surface material used. The British pendulum or similar can be used to approve a surface material. This should be combined with periodic monitoring on-site, at only at a small number of locations, during the life of the surfacing.

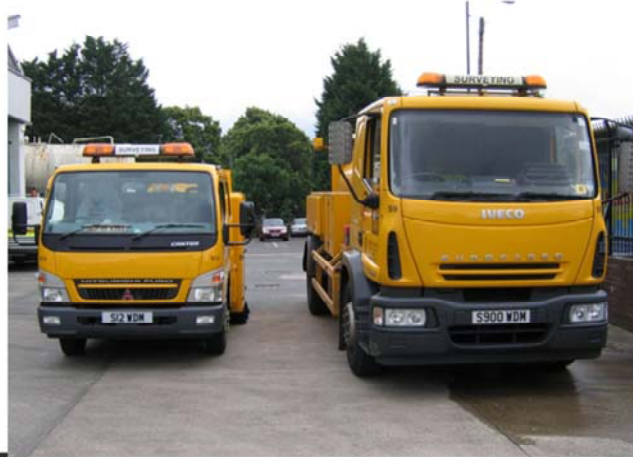
For on-road routes use SCRIM or mini-SCRIM

We reached this conclusion because only on-road routes shared with traffic is the Skid resistance likely to change significantly as polishing takes place under heavy tyre pressures. Monitoring for this situation can best be carried out with a conventional SCRIM or, depending on the situation, for example on more minor housing estate roads, using a mini SCRIM.

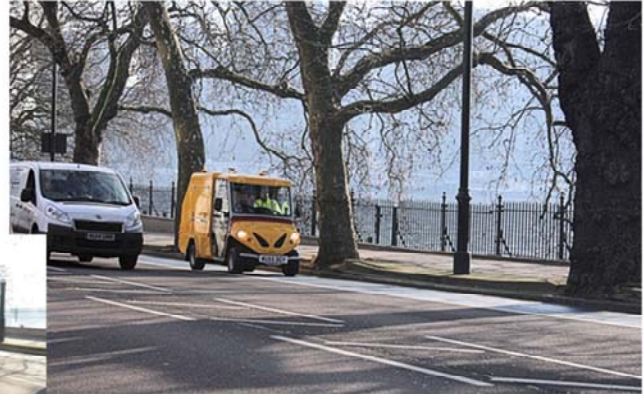
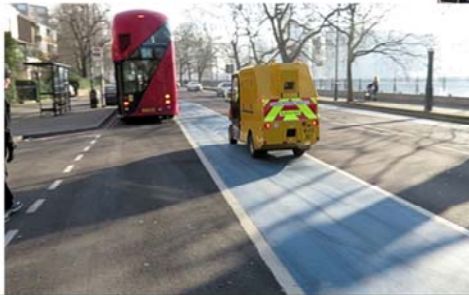
Examples of reporting data from a survey in an urban area

You can see here examples of the Cyclopath operating on cycleways in an urban area

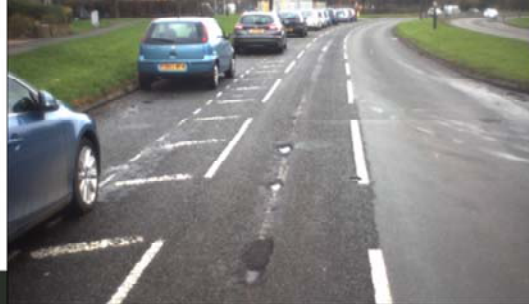
Transverse Profile Unevenness

SCANNER DEFECTS RAW TRANSVERSE PROFILE - C299, V5, XSP CL1

Data can be reported in tabular form and plotted a results over a given length of cycleway. This show the measure of transverse profile over a 1,500 m length with an image associated with the high values near the centre of the length.
