Better Roads Without Endangering Lives: Using Road Safety Audits to Maximise Development Impacts

Abstract

This paper presents a case study from the Kiribati Road Rehabilitation Project which provided an ideal scenario to prove the concept given the large number of vulnerable users and historically poor road safety performance. The risk to pedestrians was expected to increase as a result of the improved road condition, particularly from drunk drivers and speeding vehicles. The case study shows how improvements in road condition need not create roads which threaten the lives and wellbeing of the poorest members of society.

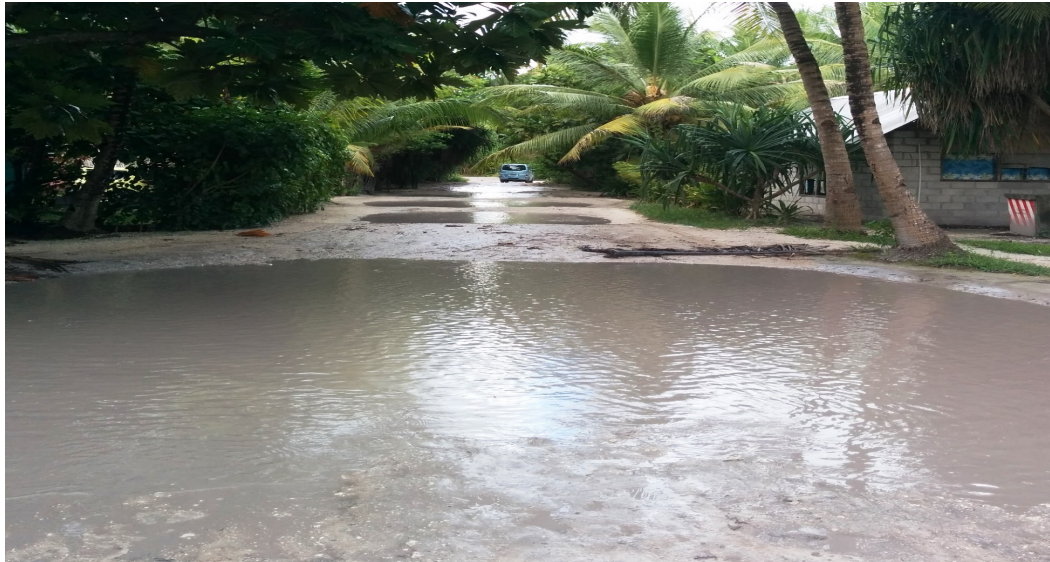
Figure 3 – Poor condition of the South Tarawa Road

While approximately 7 km of main road in Betio in the west of South Tarawa was rehabilitated in 2008 using finance from Japan, some 29 km of paved roads had received no major maintenance for over twenty years. The high traffic levels on the road combined with persistent heavy rainfall caused extensive damage, with long sections losing their surface completely and reverting to an unpaved surface.

The state and condition of the roads in Kiribati had significant economic and social repercussions; particularly with regards to the health and safety of the population. The traffic speed was reduced in places to 20 km/h or less as a result of the damage, and driving conditions were hazardous, particularly after rain (refer Figure 3). Further, during the dry season the dust from unpaved sections of the road contributed to upper respiratory problems among local residents.

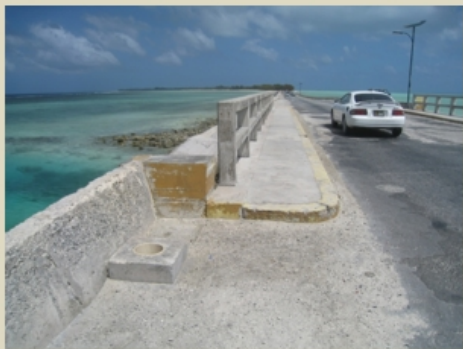
<p>The bridge on the Betio causeway is narrower than the road cross section. The footpath and the bridge railing are road side hazards that present a risk to any vehicle that is a metre or two off path.</p>

Figure 4 - Example of feasibility RSA findings showing safety concerns and recommendations (Jordan , 2010)

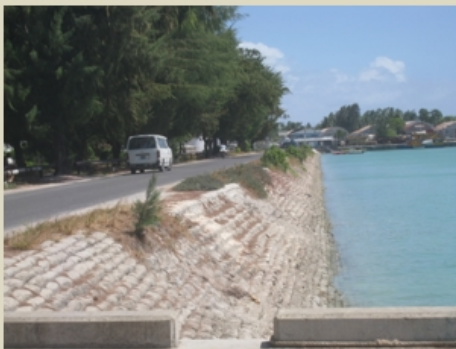
<p>The Betio port road runs beside the sea – it requires crash barrier to prevent a vehicle from dropping 4m into the sea.</p>

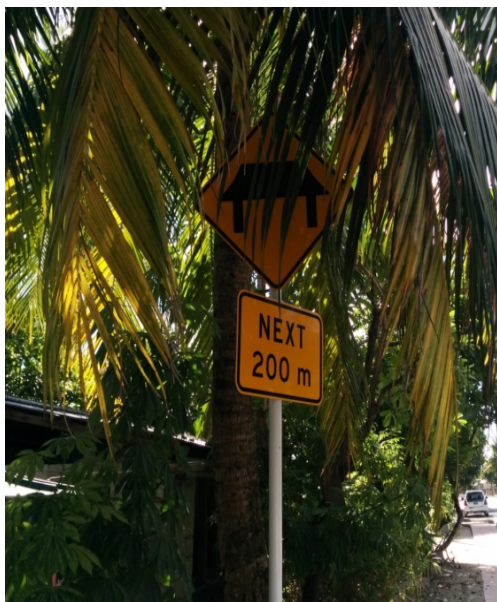
Figure 8 – Example of obscured signage issue

The post-construction RSA found a number of hazards, the majority of which were considered low risk. Hazards were classified as relating to signage, roadside hazards, intersections, lighting and other. The most common issues related to signage, which the feasibility RSA noted was almost completely absent from the road prior to rehabilitation. A particular issue was the obstruction of newly installed signage by vegetation (refer Figure 8) which could have been resolved by ongoing trimming of vegetation as part of routine maintenance (Whalley, 2017). The few high risks issues raised related to roadside hazards (including uncompleted elevated manhole risers) and bypassing of speed humps in a few locations.

In general, the auditor observed the standard of both design and construction of road safety features to be good (refer Figure 8 and 9). The RSAs at feasibility and detailed design stages resulted in a very safe design, leaving mostly minor construction issues which were relatively simple to address in line with the recommendations of the post-construction RSA.

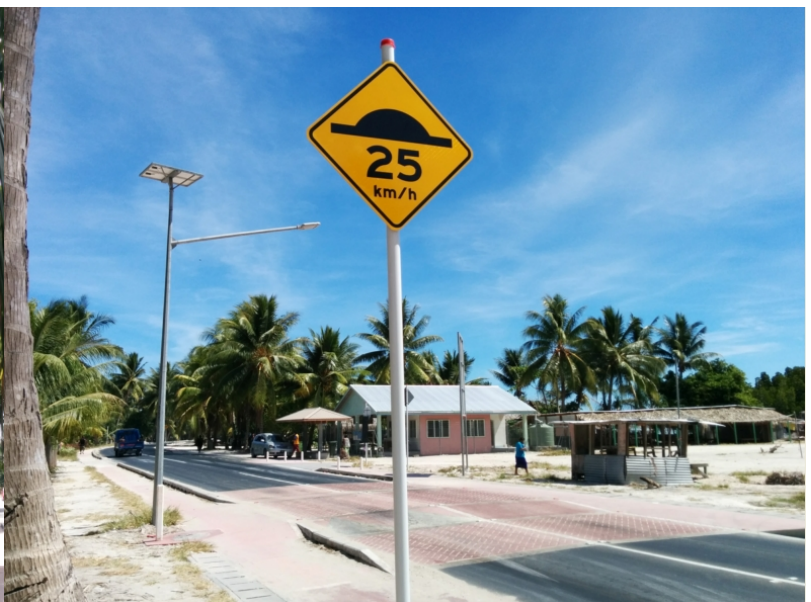
Figure 9 - Completed road showing safety features including signage,

line marking, lighting, speed humps, footpaths and drainage.
