Ultra High-pressure Watercutting – Rejuvenating the microtexture of polished surfacings

ABSTRACT

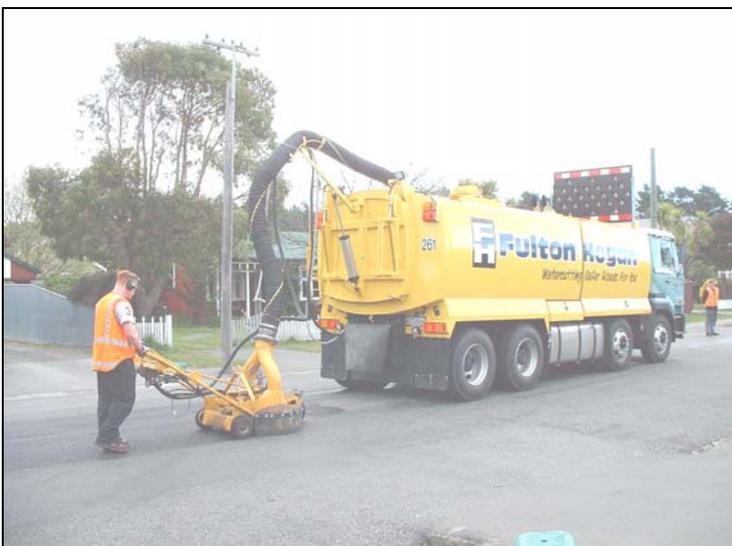
Figure 2. Water supply and vacuum recovery system

The recovered product tank on the truck has been designed to cope with the difficult material removed from the road surface. The recovered product contains approximately 20%-30% bitumen based binder and 20%-30% fine aggregate, which settles in the tank. The tank has been designed as a tipping body with a steep tipping angle and a large hydraulically operated rear door. The door seal was carefully designed to provide a watertight seal even with 8,500 litres of water and recovered product on board. The tank is constructed of stainless steel.

Optimised axle loads enable a full days supply of water and a full days worth of recovered product to be carried. This dramatically improves the efficiency of the whole operation by eliminating the need to travel to and from disposal sites during the day.
