P25 SPECIFICATION FOR HIGH SKID-RESISTANT SURFACINGS

Joanna Towler, NZ Transport Agency, New Zealand

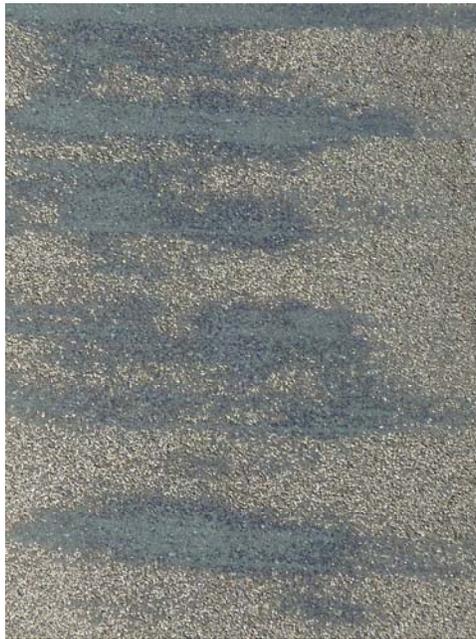
Figure 1: Calcined bauxite chip loss

- aggregate loss (see Figure 1)
- delamination of the HSRS (see Figure 2)
- failure and delamination of 'weak' substrates and in some cases their underlying pavement layers

- variability of the polyurethane/epoxy binder application rates (especially as typically hand applied)
- incorrect mixing of the binder causing adhesion failure between HSRS and substrate
- underlying surface (substrate) quality
- Ambient air and road surface temperature during and immediately following application
- Air moisture content during and immediately following application
- dusty or damp aggregate causing poor adhesion to binder
- poorly cleaned substrate prior to application of binder, affecting adhesion of HSRS
- water ingress due to e.g. poor adjacent asphalt joint sealing

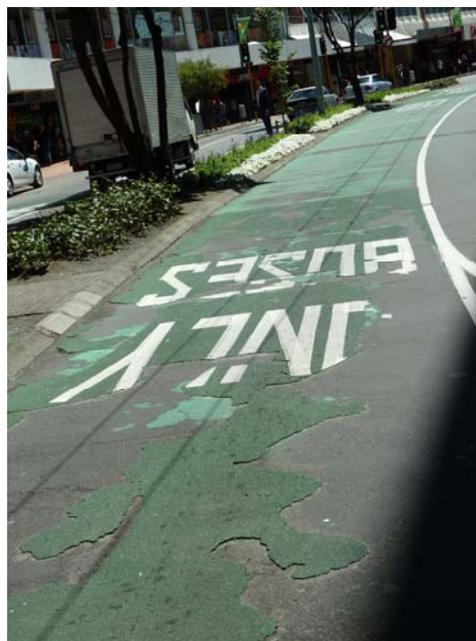
Figure 2: Surfacing delamination

Please note that if the High-Friction Surfacing delaminates from the substrate this can usually be attributed to Contractor's installation error (e.g. poorly cleaned substrate, damp substrate, damp aggregate, incorrect mixing of binder components, poor thickness of binder, poor choice of binder and its quality etc).
